TECHNICAL INSTRUCTIONS

SAFETY RECALL BLB

PLASTIC PAD MODIFICATION

2006 – Early 2007 MODEL YEAR GS 300 and GS 350 AWD

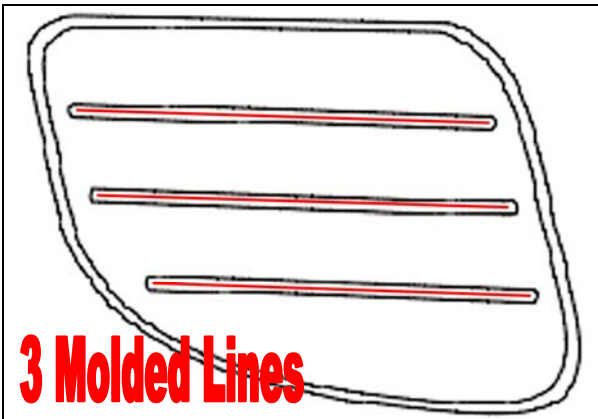
- a) If the plastic pad shape is as shown, the vehicle ***IS NOT*** affected. The campaign is completed.

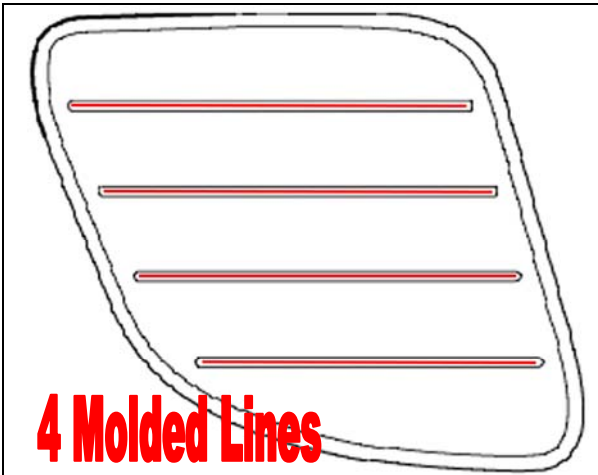
- b) If the plastic pad shape is as shown, continue to **STEP B** (Modify the plastic pad).

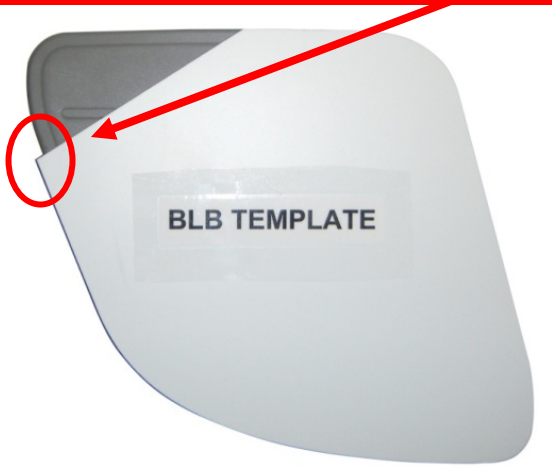
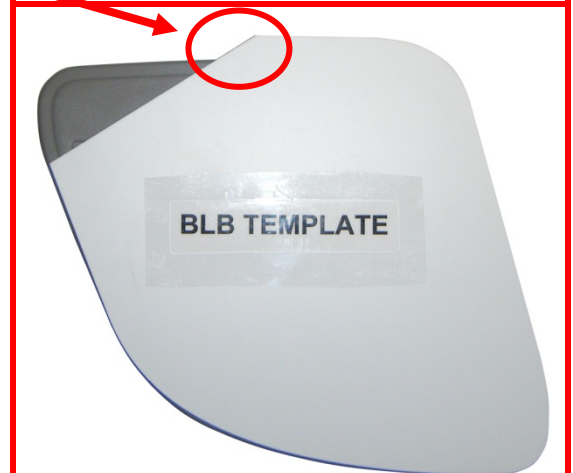
INCORRECT ALIGNMENT

DO NOT mis-align the template when marking the plastic pad. If the template is positioned incorrectly, the plastic pad will not be marked correctly.
