**PREVOST**

**SAFETY  
RECALL**

Sr11-10

DATE : MARCH 2011	SECTION : 03-FUEL
SUBJECT : REPLACEMENT OF THE FUEL TANK SUPPORT

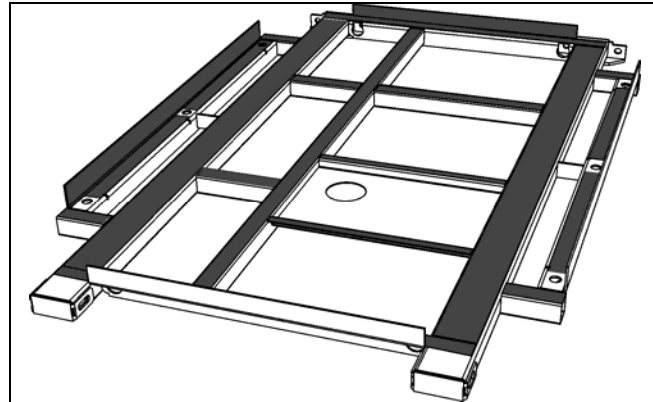
APPLICATION OF SELF-ADHESIVE NEOPRENE FOAM (dark area)

3. Apply self-adhesive neoprene foam (p/n 506758) on the new platform as shown.
4. Lift the vehicle.

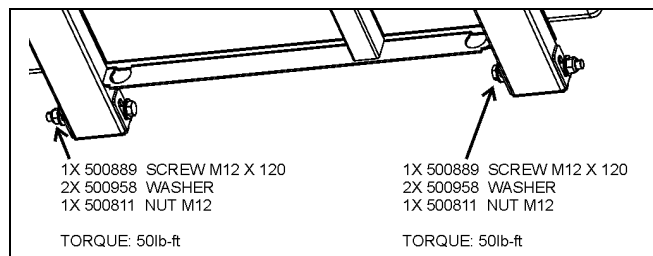
1X 500889 SCREW M12 X 120  
2X 500958 WASHER  
1X 500811 NUT M12

TORQUE: 50lb-ft

7. Unscrew the bolts (6) holding the fuel tank support to the vehicle chassis.
8. Replace the existing fuel tank support with the new one. Identify the defective support so it will not be reuse.
9. Install the new support with **new** bolts, washers and nuts.
  - Tighten bolts to 50 lb-ft (5 bolts)
  - Tighten bolts to 25 lb-ft (with static wick)
