# HYUNDAI Technical Service Bulletin

Group	CAMPAIGN
Number	11-01-010
Date	APRIL, 2011
Model	2007 - 2009 ELANTRA

Subject  
**WCS CONNECTOR VINYL COVER INSTALLATION & AIRBAG CONTROL UNIT REPROGRAMMING (CAMPAIGN 099 & CAMPAIGN 100)**

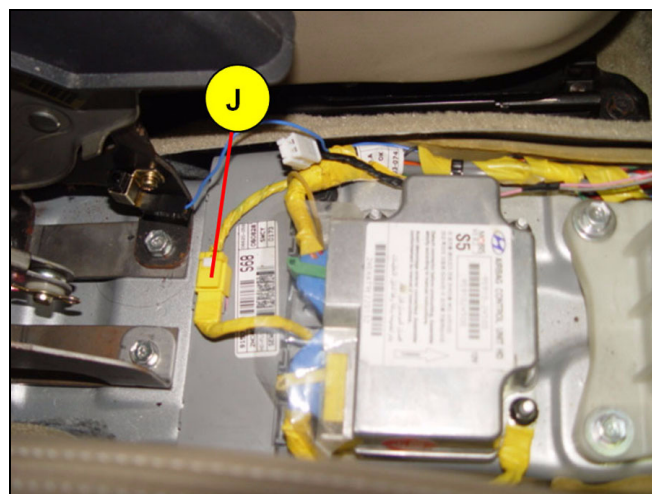
- Locate the Weight Classification System wiring connector (J), which is positioned to the rear of the Airbag Control Unit.

**NOTE:** This connector is identified as AA11 in the airbag system section of the ETM for the affected vehicles.

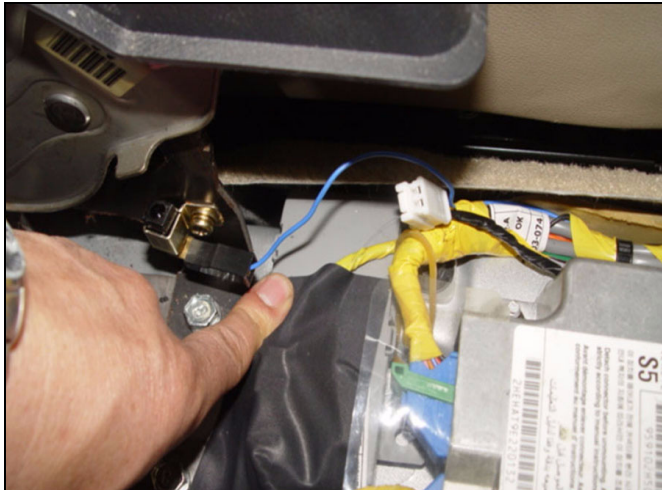
Campaign 099 provides the procedure to install a protective cover over the Weight Classification System (WCS) wiring connector to prevent contamination from liquid spills. If the connector is contaminated, it may result in airbag warning light illumination.

12. Attach the vinyl cover onto the Weight Classification System connector as shown in the photo. Use your finger to evenly press down on the vinyl cover.
