NOTICE: Revised Defect Information Notice – concerning Spindle Nuts and Stake Washer on certain ArvinMeritor TL Series trailer axles.

ArvinMeritor File: C11AB

NHTSA File: 10E-058

Procedures and Intervals to Inspect the Wheel Ends and Tighten the Spindle Nuts on Meritor TL Series Trailer Axles with Unitized Wheel Ends

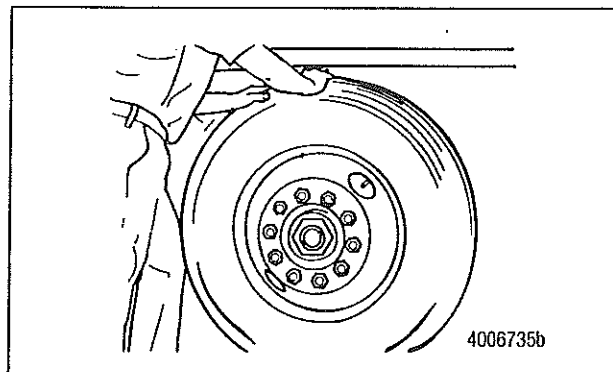
Figure 1

4. Grasp the tire and wheel-end assembly at the 12 and six o'clock positions. Check for vertical and horizontal movement. With your hands, apply approximately 50 lb (23 kg) of force to the assembly. You should not feel or see any looseness or movement. Figure 1.

- **If you feel or see movement at the tire circumference:** Proceed to the Detailed Hub Inspection procedure.
- **If no movement is detected:** Proceed to the Quick Clamp Load and Inspection procedure.

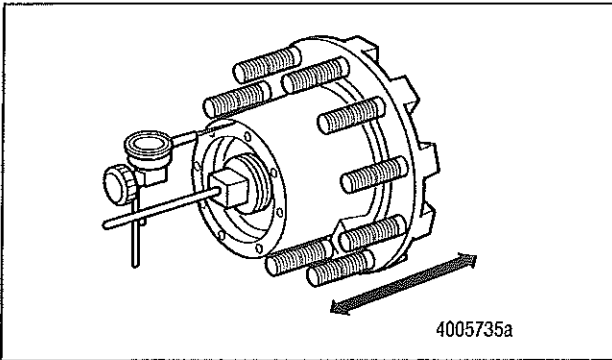
Figure 5

4. Set the dial indicator to ZERO. Do not rotate the wheel end. Place your hands at the nine and three o'clock positions.
5. Push the unitized wheel end straight IN. Note the reading. Then pull the wheel end straight OUT. Note the reading.
 - If the total movement of the dial indicator is less than 0.003-inch (0.08 mm): Follow Instructions 2 through 11 in the Quick Clamp and Load Inspection procedure.
 - If the total movement is 0.003-inch (0.08 mm) or greater: Proceed to the Thread Inspection procedure.

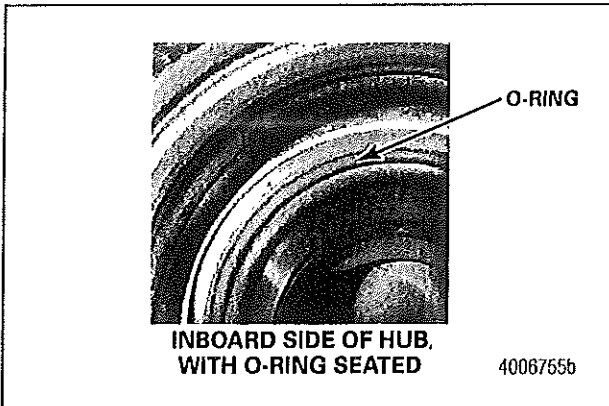
Figure 12

NOTE: Previous versions of TL hubs may or may not have an O-ring on the inboard side of the hub. All replacement hubs will include an O-ring. This O-ring must be installed with the replacement hub regardless of previous hub arrangement.

1. Ensure the O-ring (part number AM1205Q2747) between the bearing cartridge and the spindle shoulder is inserted into the groove and in place when the hub is installed. Figure 12.
