## ABS WIRING UPDATE PROCEDURE

Stoneridge Instrument Cluster ABS  
Malfunction Indicator Noncompliance

# RECALL

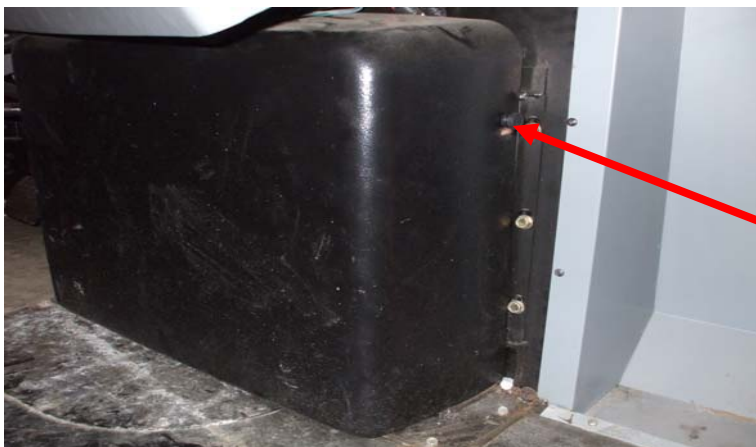
Thumb screws.  
Cover is located  
lower center of  
dash.

1. Park the bus on a level surface, apply parking brakes, turn off engine and remove keys. Chock wheels.
2. Disconnect batteries – Note; When disconnecting the batteries, remove the negative cable first.
3. Remove chassis Power Distribution Unit (PDU) cover by removing two thumb screws. The thumb screws are located at the top of each side of the cover.

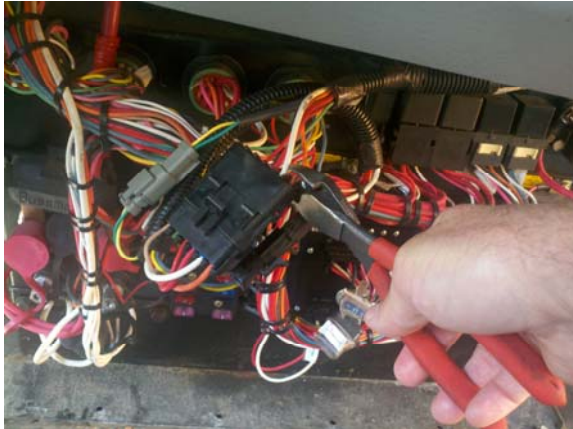
4. Locate connector C504 in PDU (detail shown below). Cut and remove connector C504 from the PDU and ABS harness.

5. Splice each circuit from previous step to the corresponding circuit. Use appropriate terminal as listed below.

Remove two “C504” connectors and splice each circuit to the corresponding circuit.

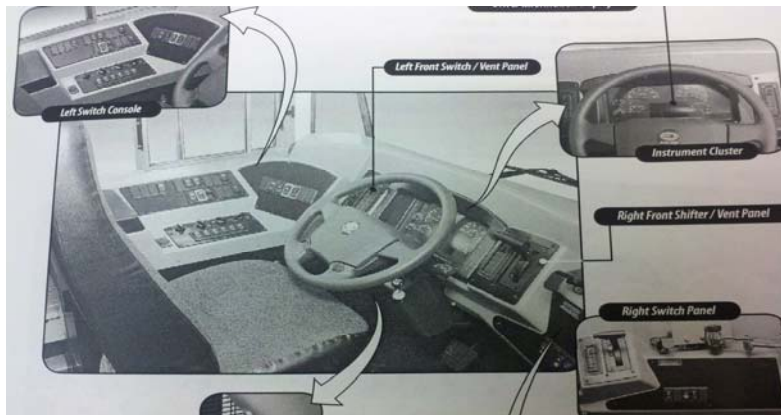
Diagnostic Switch located in this panel.

8. Blink code 1-1 indicates system OK and no fault codes. Any other blink code indicates a fault code. If any fault code exists please refer to maintenance manual 39 included in your Vision service manual.
9. ABS wiring update procedure is complete.
