**NOTICE:** Defect Information Report, in accordance with 49 CFR §573.6, concerning certain bolts supplied by General Fastener Corporation and assembled into ArvinMeritor MC14 & MC16 type TAG axles.

ArvinMeritor File: C11AC

NHTSA File: 11E-007

## Replacing the Torque Plate-to-Spindle Flange Fasteners on Meritor MC16 Series Tag Axles on Certain Motor Coach Industries (MCI®) J-Coach Units

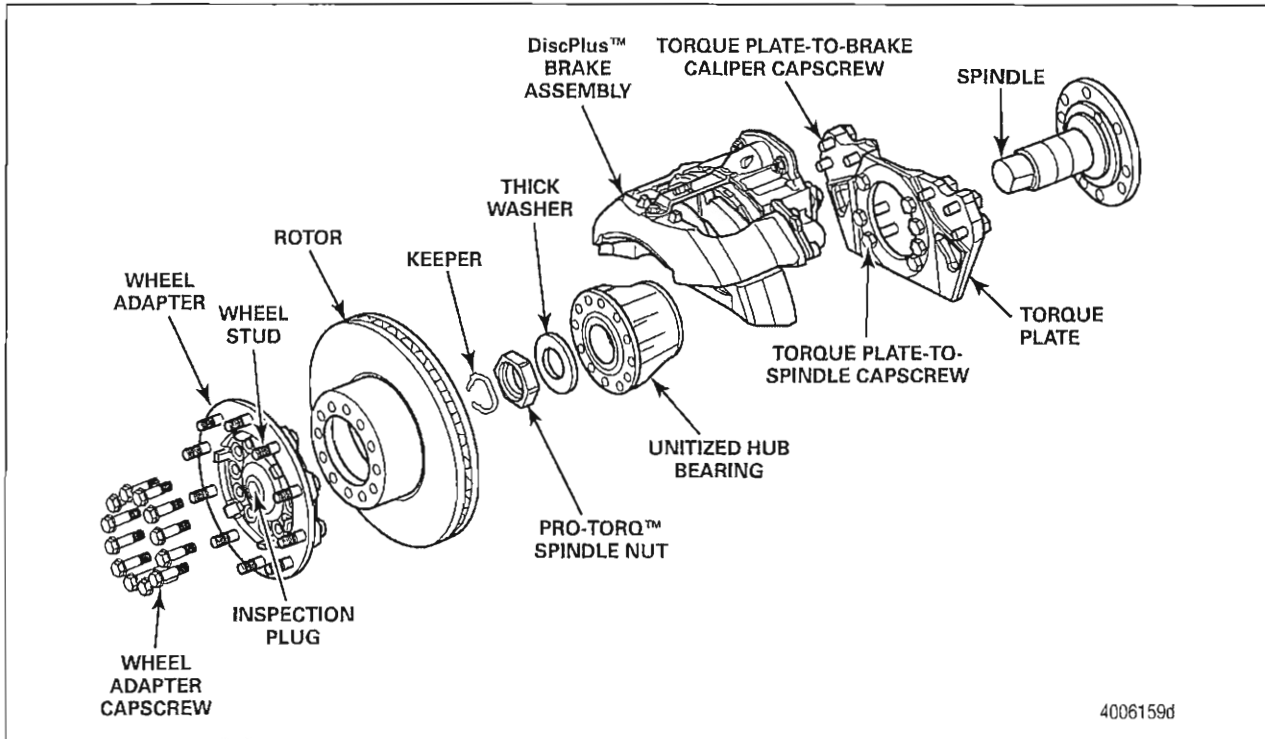
Refer to Figure 1 for an illustration of the MC16 Series tag axle wheel end.

1. Remove the torque plate-to-spindle flange fasteners. Figure 1.
2. Set the fasteners aside to destroy once the repair is complete.

1. Using the new fasteners provided in the kit supplied by the OEM, assemble the torque plate to the spindle flange.
2. Tighten the new fasteners to 326-420 lb-ft (440-570 N•m).
