RECALL BULLETIN:
110318FRV

PRODUCT(S) AFFECTED:
Discovery,
Providence,
Revolution LE

SUBJECT:
Inspection/
Correction of
Interior Lighting
Dimmer
Switches

ISSUE DATE:
June 2011

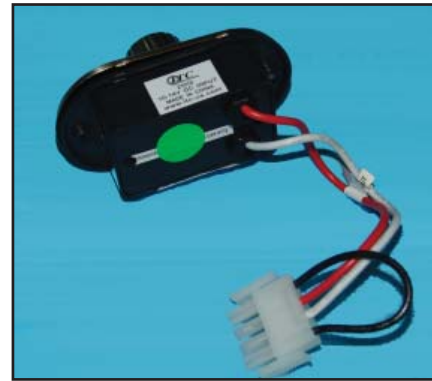
Figure 2

- A. If a round green label is found on the outside of the switch housing as shown in Figure 2, the switch is considered to be of a corrected design and should be reinstalled.
- B. If there is no round green label on the outside of the switch housing as shown in Figure 1, look at the white label on the side of the switch housing:
 - If the number printed under the ITC logo is 21005 and there are four wires exiting the switch's housing, the switch is not included in the recall and it should be reinstalled.
 - If the number printed under the ITC logo is 21010 (and there is no green label) the switch must be replaced according to the CORRECTION procedures below.

Dimmer switches of a corrected design will be marked with a round green label as shown, or will be a four-wire switch marked with part number 21005 under the ITC logo.

If the switch has two wires exiting the housing, its part number printed under the ITC logo is 21010, and there is no green label, the switch must be replaced.

5. Unplug and discard the defective dimmer switch.
6. Plug in the replacement dimmer switch, fasten with screws, and install the cover and knob.
7. Enable the 12 volt power using the battery disconnect.
8. Test the operation of the lights using the new dimmer switch; correct as necessary.
