Safety Recall Circular

Code: 97V3

Subject: 2011 Jetta Sedan (6th Generation)
Converter Box Wiring

REVISED
UNITED STATES ONLY March 30, 2011

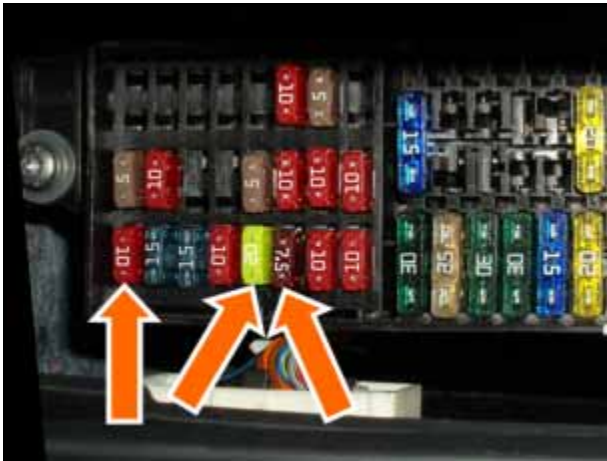
⇐ Check lower left fuse panel for presence of all three fuses <arrows> as listed below:

- Fuse 10A (red) – position 17
- Fuse 20A (yellow) – position 21
- Fuse 7.5A (brown) – position 22

⇐ If all three fuses <arrows> are present, **WORK COMPLETE, Continue to Section H**

⇐ If all three fuses <arrows> are not present, **continue to Section B**
