RECALL CAMPAIGN BULLETIN

NTB11-039a June 16, 2011

VOLUNTARY SAFETY RECALL CAMPAIGN 1996 - 2004 PATHFINDER FRONT STRUT HOUSING CORROSION INSPECTION

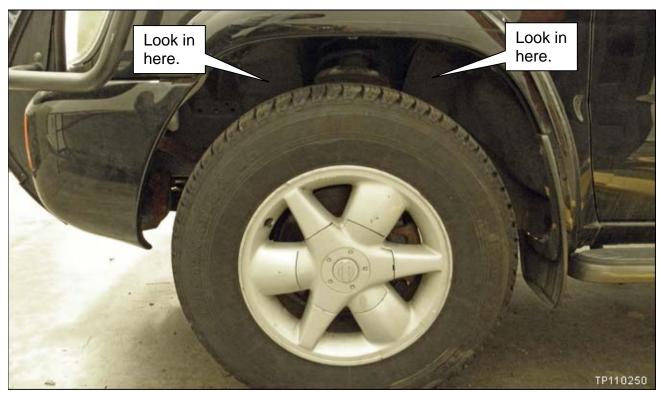
Figure 1

- 1. Turn the ignition OFF.
- 2. Set the parking brake.
- 3. Inspect the brake master cylinder and the brake line to the left front wheel for any damage.
- 4. Look behind the driver side tire in the two areas shown in Figure 1.

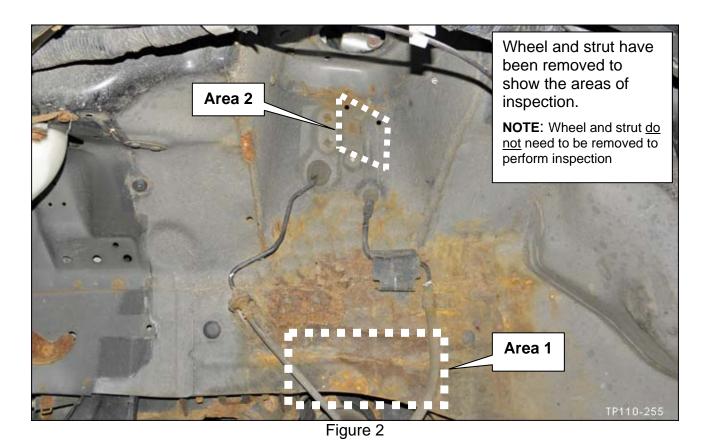
5. Inspect for corrosion in <u>area 1</u> and <u>area 2</u> (see Figures 2, 3, and 4).

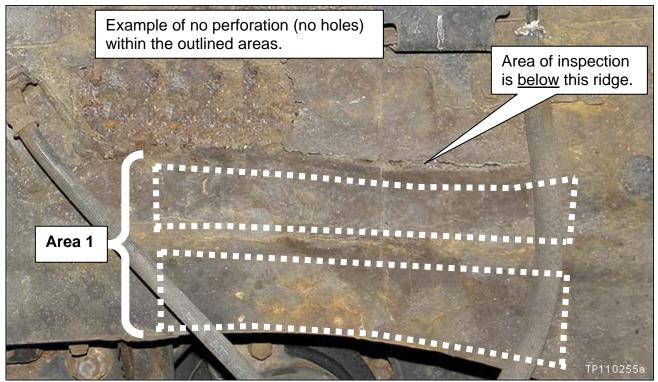
Figure 3

Area 1: Look for perforation (holes) in the metal only in the areas outlined.

If there is perforation (holes) in the metal:

- a. Retain the vehicle at the dealer (the vehicle is not repairable).
- b. Supply the customer with a rental car.
- c. Fax a completed Non-Repairable Report (see page 15) to your regional office.

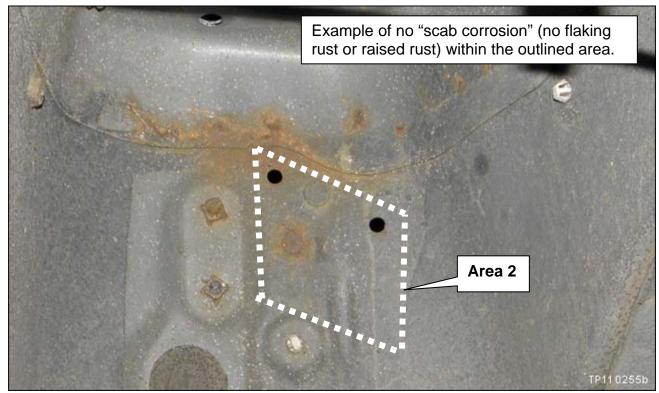
Figure 4

Area 2: Look for "scab corrosion" (flaking rust or raised rust) only in the area outlined.

If there is scab corrosion (flaking or raised rust):

- a. Retain the vehicle at the dealer (the vehicle is not repairable).
- b. Supply the customer with a rental car.
- c. Fax a completed Non-Repairable Report (see page 15) to your regional office.

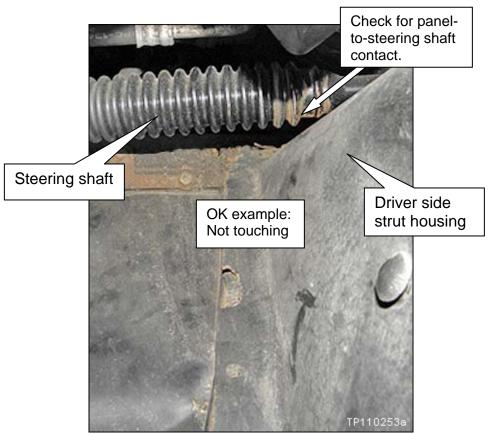
Figure 8

4. Check for driver side strut housing panel to steering shaft contact (see Figure 8).

Panel is touching the steering shaft:

- a. Retain the vehicle at the dealer (vehicle is repairable but **cannot** be driven).
- b. Supply the customer with a rental car until the repair is available.

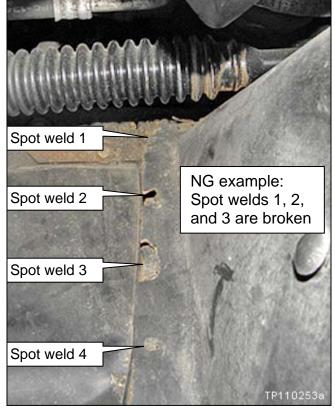
Figure 9

5. Check the spot welds on the front of the driver side strut housing panel (see Figures 9 and 10).

Not Drivable - Spot weld 3 is broken:

- No spot welds broken
- Spot weld 1 is broken
- Spot welds 1 and 2 are broken
 - a. Reinstall the 4 air filter box mounting bolts/nuts.
 - b. Release the vehicle to the customer.
 - c. Inform the customer of the following:
 - Nissan will contact them in the near future with instructions for obtaining additional repairs.
 - If the customer experiences an increased steering effort or difference in the vehicle handling, they should return to the dealer immediately for a repeat inspection.

- a. Retain the vehicle at the dealer (vehicle is repairable but cannot be driven).
- b. Supply the customer with a rental car until the repair is available.

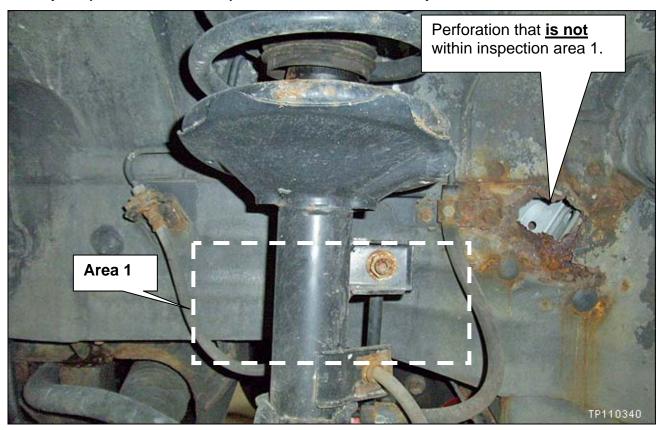
Examples (Additional Photos) of Area 1 Perforation Inspection

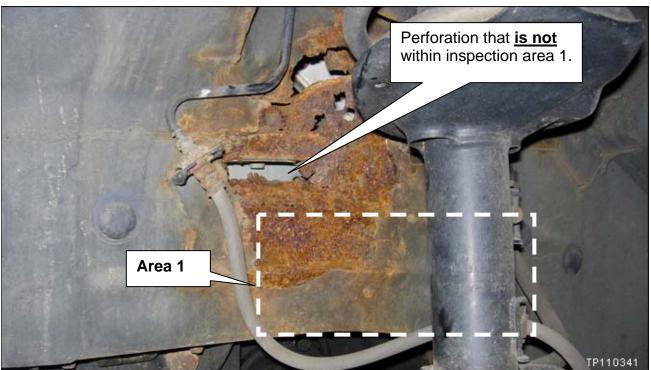
Example (Additional Photo) of Area 1 Perforation Inspection

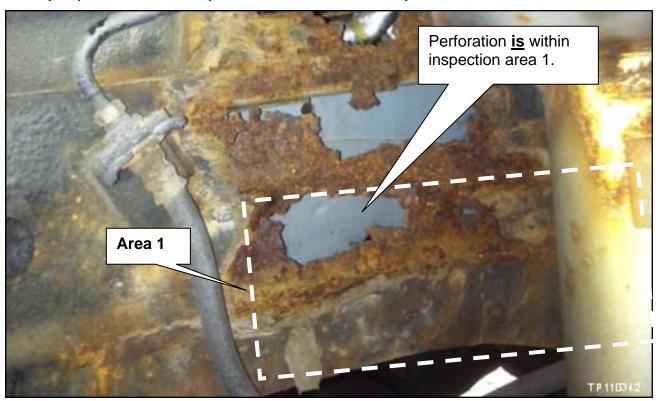
Example (Additional Photo) of Area 1 Perforation Inspection

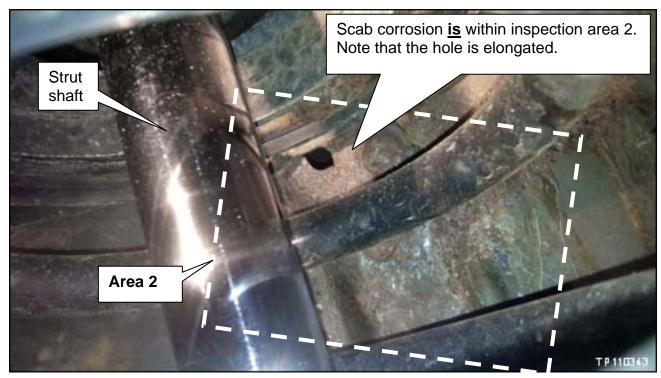
Example (Additional Photo) of Area 2 Scab Corrosion Inspection
