Re: Toyota Safety Recall 11V-245 - Updated Remedy Instructions

SAFETY RECALL B0E

CURTAIN SHIELD AIRBAG (CSA) SENSOR

CERTAIN 2008 MODEL YEAR HIGHLANDER / HV

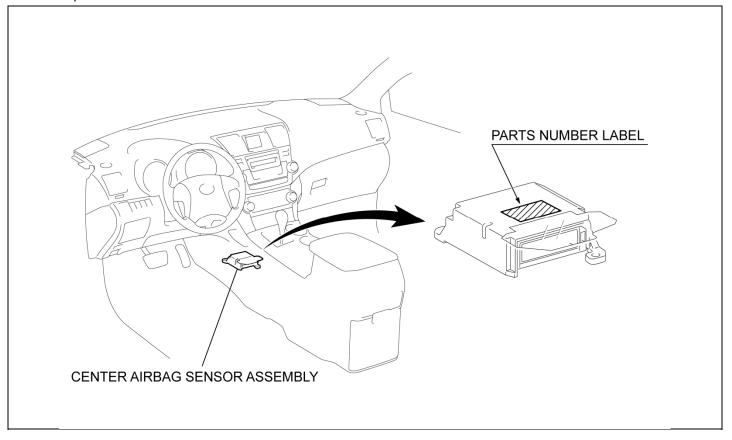
In the curtain shield airbag (CSA) system of the subject vehicle, there are two sensors in the airbag sensor assembly which are designed to detect vehicle roll angle. If one of these sensors malfunctions, the airbag warning light (Malfunction indicator Light: MIL) will illuminate and the roll detection system will be suspended; however, the airbag (CSA) remains available in the event of a side crash. If both sensors fail nearly simultaneously after initial airbag system check, the CSA and the seat belt pretensioner could be inadvertently activated. Inadvertent activation of the CSA and/or the seat belt pretensioner can cause injury to a vehicle occupant.
