File In Section: Product Recalls  
Bulletin No.: 11149A  
Date: May 2011

## PRODUCT SAFETY RECALL

**SUBJECT:** Intermediate Steering Shaft Separation

**MODELS:** 2011 Chevrolet Cruze

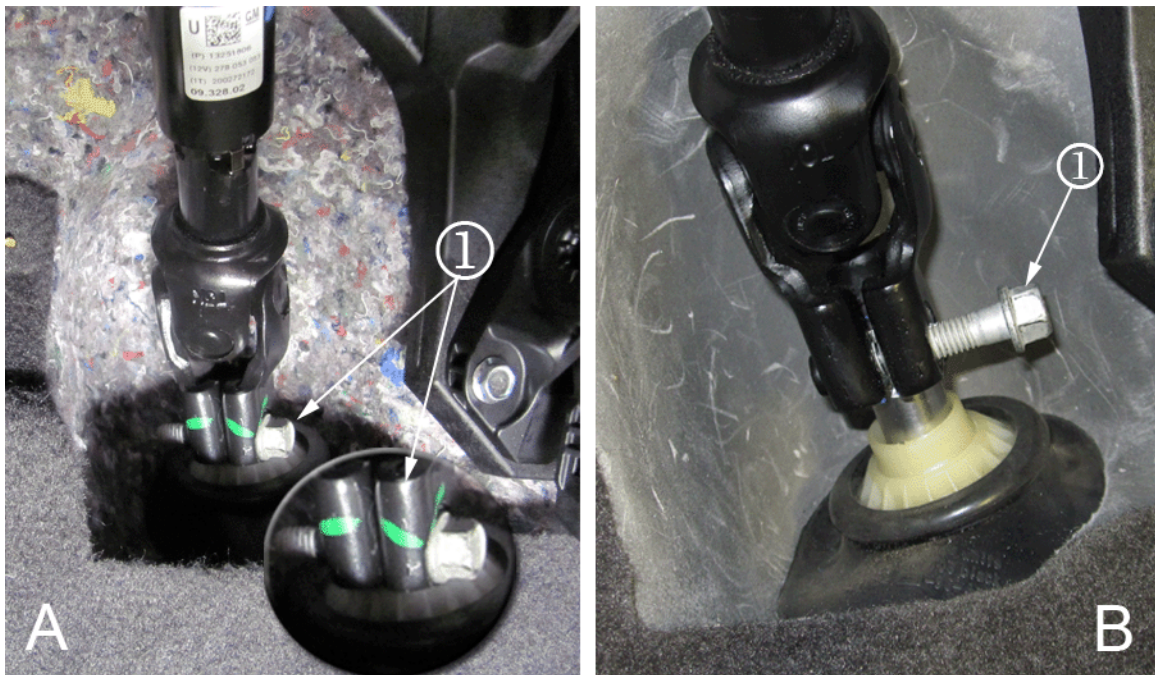
2652177

General Motors has decided that a defect, which relates to motor vehicle safety, exists in **certain** 2011 model year Chevrolet Cruze vehicles. On some of these vehicles, the bolt attaching the intermediate steering shaft to the steering gear input shaft may not have been properly installed. This could allow the joint to separate, resulting in the loss of steering. If this happens while the vehicle is moving, a crash could occur without prior warning.

(A) Lower Intermediate Steering Shaft Bolt Fully Seated

(B) Lower Intermediate Steering Shaft Bolt NOT Seated

(1) Lower Intermediate Steering Shaft Bolt.

- Inspect the intermediate steering shaft for a fully seated lower intermediate steering shaft bolt. Refer to the illustration. Portion "A" of the illustration shows a fully seated bolt. Portion "B" of the illustration shows a bolt that is not fully seated.
  - If the lower intermediate steering shaft bolt is fully seated and tightened to minimum of 25 N•m (18 lb-ft), proceed to Step 3.

- If the lower intermediate steering shaft bolt is NOT fully seated, replacement of the intermediate steering shaft, intermediate shaft bolts and steering gear is required. Refer to the “B” portion of the illustration. Proceed to Step 2.

2. Replace the steering gear and intermediate steering shaft. Refer to *Steering Gear Replacement* and *Intermediate Steering Shaft Replacement* in SI. Proceed to Step 3 after completing repairs.
