Recall Bulletin

PRODUCT SAFETY RECALL

SUBJECT: Intermediate Steering Shaft Separation

MODELS: 2011 Chevrolet Cruze

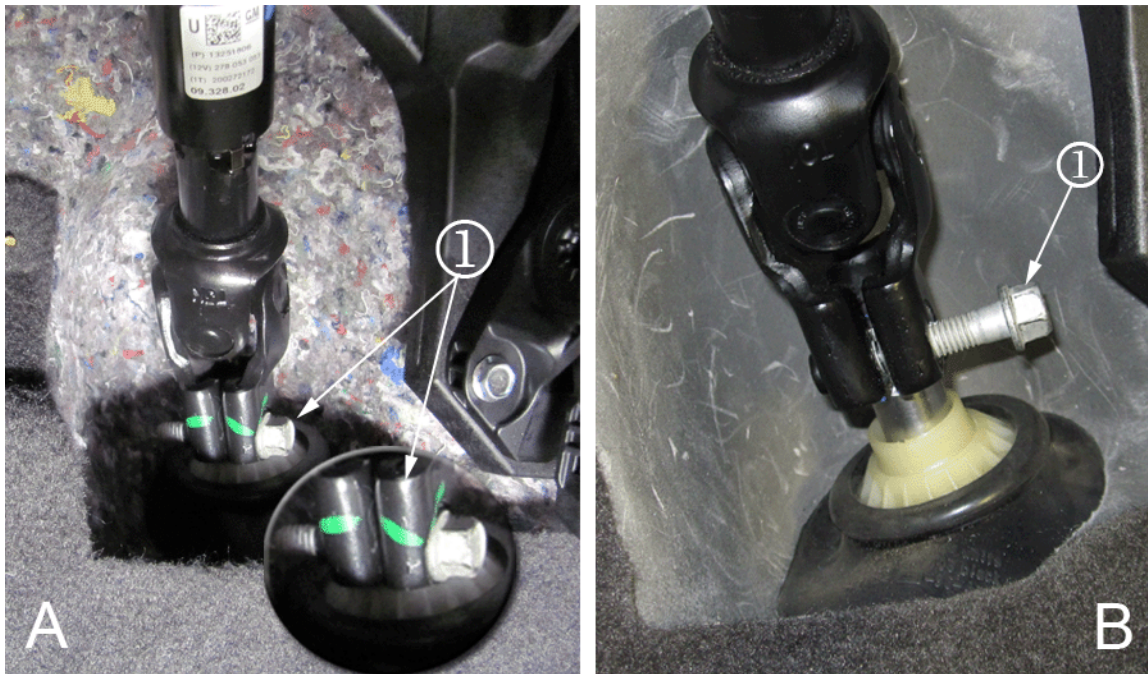
2652177

- (A) Lower Intermediate Steering Shaft Bolt Fully Seated
 (B) Lower Intermediate Steering Shaft Bolt NOT Seated
 (1) Lower Intermediate Steering Shaft Bolt.

- Inspect the intermediate steering shaft for a fully seated lower intermediate steering shaft bolt. Refer to the illustration. Portion "A" of the illustration shows a fully seated bolt. Portion "B" of the illustration shows a bolt that is not fully seated.
 - If the lower intermediate steering shaft bolt is fully seated and tightened to minimum of 25 N•m (18 lb-ft), proceed to Step 3.
 - If the lower intermediate steering shaft bolt is NOT fully seated, replacement of the intermediate steering shaft, intermediate shaft bolts and steering gear is required. Refer to the "B" portion of the illustration. Proceed to Step 2.

2. Replace the steering gear and intermediate steering shaft. Refer to *Steering Gear Replacement* and *Intermediate Steering Shaft Replacement* in SI. Proceed to Step 3 after completing repairs.
