PRODUCT SAFETY RECALL

SUBJECT: Intermediate Steering Shaft Separation

MODELS: 2011 Chevrolet Cruze

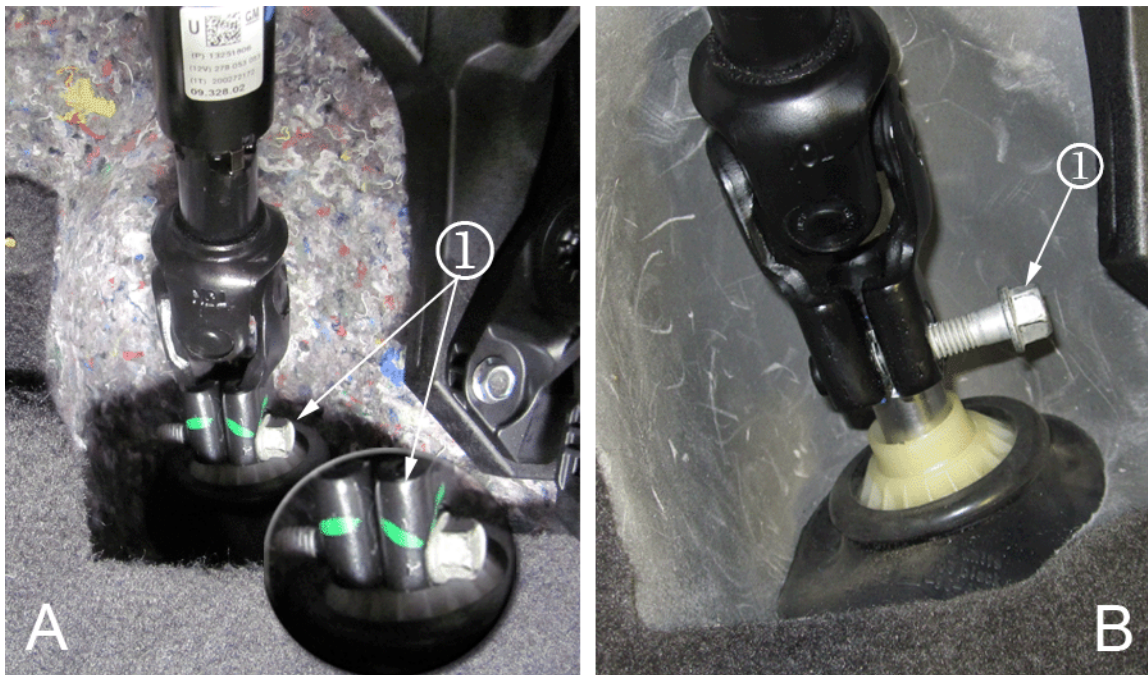
2652177

- (A) Lower Intermediate Steering Shaft Bolt Fully Seated
 (B) Lower Intermediate Steering Shaft Bolt NOT Seated
 (1) Lower Intermediate Steering Shaft Bolt.

- Inspect the intermediate steering shaft for a fully seated lower intermediate steering shaft bolt. Refer to the illustration. Portion "A" of the illustration shows a fully seated bolt. Portion "B" of the illustration shows a bolt that is not fully seated.
 - If the lower intermediate steering shaft bolt is fully seated and tightened to minimum of 25 N•m (18 lb-ft), proceed to Step 3.
 - If the lower intermediate steering shaft bolt is NOT fully seated, replacement of the intermediate steering shaft, intermediate shaft bolts and steering gear is required. Refer to the "B" portion of the illustration. Proceed to Step 2.

2. Replace the steering gear and intermediate steering shaft. Refer to *Steering Gear Replacement* and *Intermediate Steering Shaft Replacement* in SI. Proceed to Step 3 after completing repairs.
