Recall Bulletin

PRODUCT SAFETY RECALL

SUBJECT: Intermediate Steering Shaft Separation

MODELS: 2011 Chevrolet Cruze

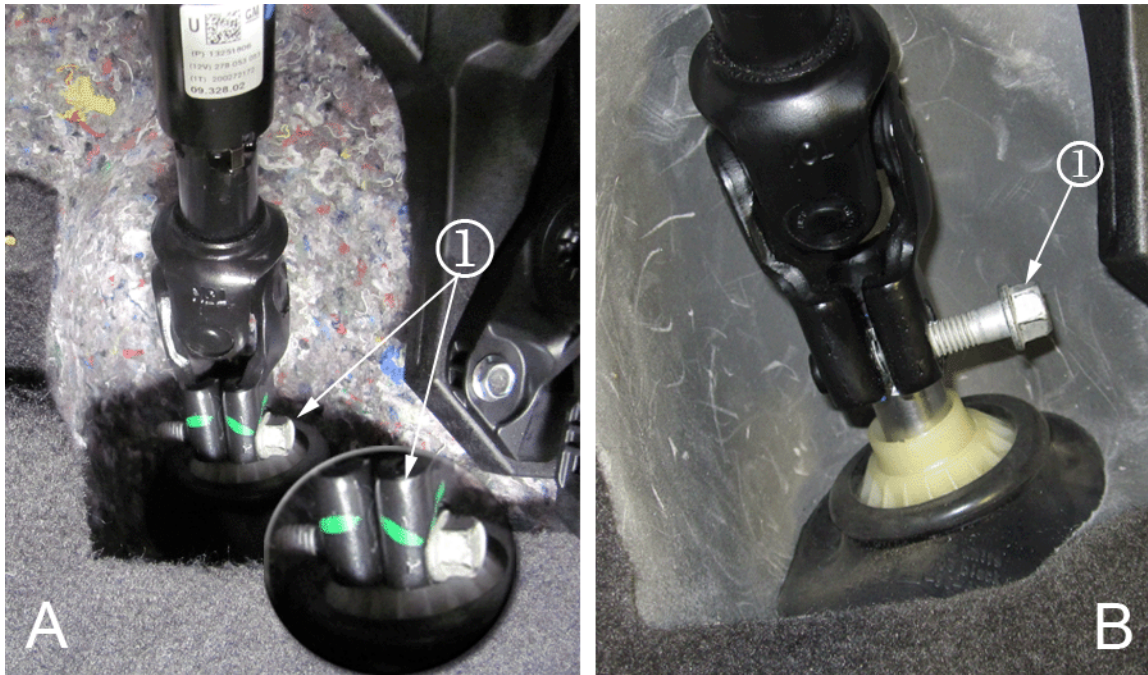
2652177

General Motors has decided that a defect, which relates to motor vehicle safety, exists in **certain** 2011 model year Chevrolet Cruze vehicles. On some of these vehicles, the bolt attaching the intermediate steering shaft to the steering gear input shaft may not have been properly installed. This could allow the joint to separate, resulting in the loss of steering. If this happens while the vehicle is moving, a crash could occur without prior warning.

(A) Lower Intermediate Steering Shaft Bolt Fully Seated
 (B) Lower Intermediate Steering Shaft Bolt NOT Seated
 (1) Lower Intermediate Steering Shaft Bolt.

- Inspect the intermediate steering shaft for a fully seated lower intermediate steering shaft bolt. Refer to the illustration. Portion “A” of the illustration shows a fully seated bolt. Portion “B” of the illustration shows a bolt that is not fully seated.
 - If the lower intermediate steering shaft bolt is fully seated and tightened to minimum of 25 N•m (18 lb-ft), proceed to Step 3.
 - If the lower intermediate steering shaft bolt is NOT fully seated, replacement of the intermediate steering shaft, intermediate shaft bolts and steering gear is required. Refer to the “B” portion of the illustration. Proceed to Step 2.
- Replace the steering gear and intermediate steering shaft. Refer to *Steering Gear Replacement* and *Intermediate Steering Shaft Replacement* in SI. Proceed to Step 3 after completing repairs.
