File In Section: Product Recalls
Bulletin No.: 11142
Date: May 2011

Recall Bulletin

SUBJECT: Shift Lever May Not Display Correct Gear

MODELS: 2011 Chevrolet Cruze
Equipped with an Automatic Transmission

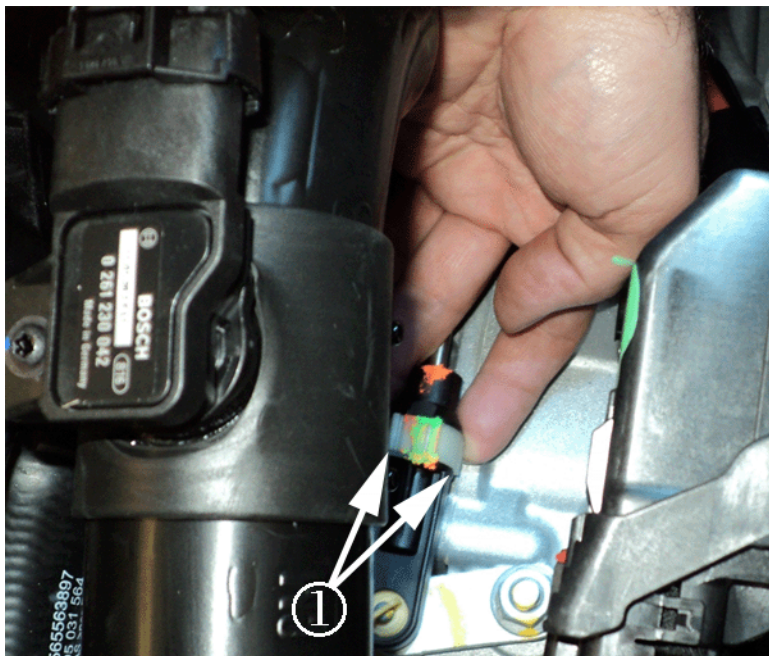
3. Place index and middle fingers under edges of the white transmission range selector lever cable adjust lock (locking clip) (1) on top of shifter arm assembly. Attempt to lift both sides of the white clip out of the shifter arm linkage to validate the white clip is fully seated. If the white clip is fully seated, it will NOT lift out of the shifter arm linkage assembly.
4. If the white locking clip lifts out of its locked position, replace the clip. Install a new clip, seating it firmly, and repeat the test.

Note: The white locking clip will produce a notable click when it is properly seated and snapped into place. Ensure that the adjust lock "clicks" into its locked position.
