File In Section: Product Recalls  
Bulletin No.: 11142B  
Date: June 2011

# Recall Bulletin

**SUBJECT:** Shift Lever May Not Display Correct Gear

**MODELS:** 2011 Chevrolet Cruze  
Equipped with an Automatic Transmission

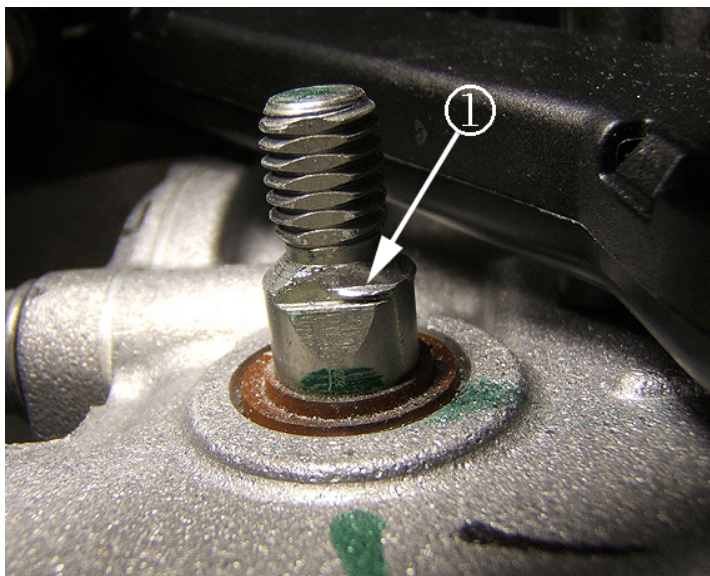
2647515

11. Inspect the flats on both sides of the transmission manual shaft for a burr or metal ridge (1). If a burr exists continue below, otherwise skip to Step 20.

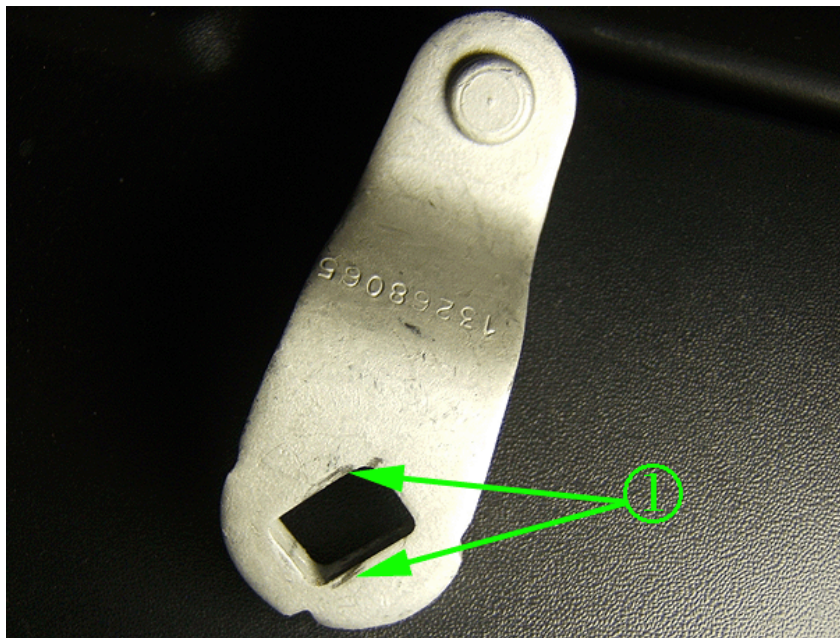
2650633

16. Remove and examine the transmission range selector lever. Confirm that the rectangular receiver in the lever has not been deformed. It is expected that a witness mark (1) on the bottom of the lever may exist (as shown) from contact with the now removed burr. Minor marks at the edge of the receiver will not affect proper operation. Only replace the lever if significant (easily seen) deformation / rounding of the receiver hole exists

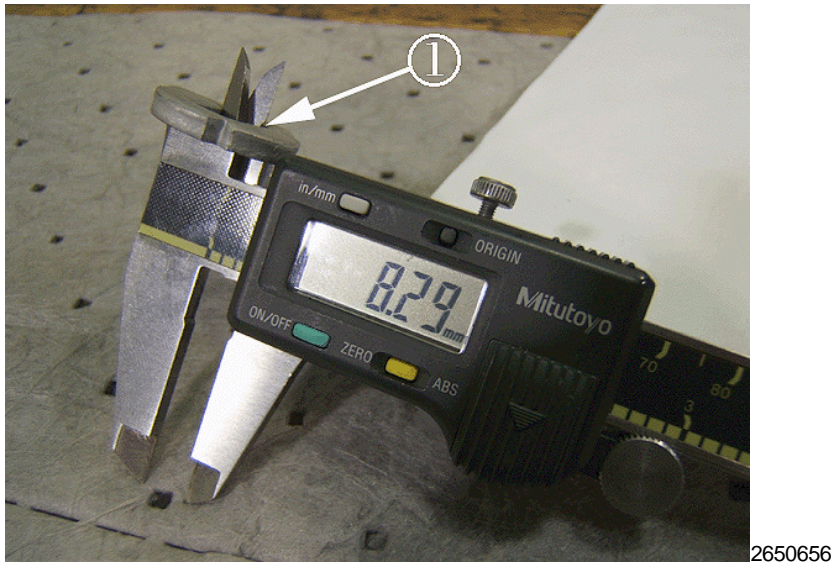
18. Using a caliper, measure the inside of the transmission range selector lever rectangular receiver (1).
19. The difference between the readings across the flats of transmission manual shaft and the inside diameter of the levers mating surface must not be more than 0.2 millimeters or the transmission manual shaft must be replaced.

**Example:** If the transmission manual shaft measures 8.18mm and the inside diameter of the levers mating surface measures 8.29mm as shown above, the difference is 0.11mm and an acceptable fit.

**Caution:** IF MEASURED CLEARANCE EXCEEDS 0.2MM, REPLACEMENT OF THE MANUAL SHAFT IS NECESSARY. REFER TO THE "MANUAL SHIFT DETENT LEVER WITH SHAFT POSITION SWITCH ASSEMBLY REPLACEMENT" PROCEDURE IN SI. IF REPLACEMENT IS REQUIRED, SUBMIT REPLACEMENT UNDER NORMAL WARRANTY.
