Recall Bulletin

F/CMVSS NONCOMPLIANCE RECALL

SUBJECT: Shift Lever May Not Display Correct Gear

MODELS: 2011 Chevrolet Cruze
Equipped with an Automatic Transmission

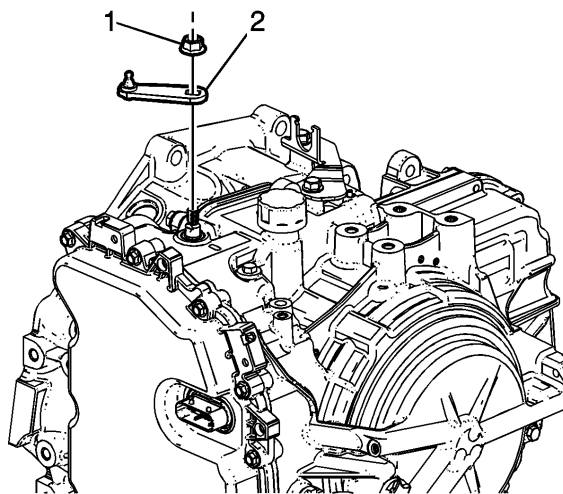
2001183

Warning: Hold the transmission range selector lever while removing or installing the lever retaining nut. Excessive torque on the manual shaft can damage the detent lever hub retainer which could allow the vehicle to roll when placed in the park position.

9. Remove the transmission range selector nut (1).

10. Remove the transmission range selector lever (2)

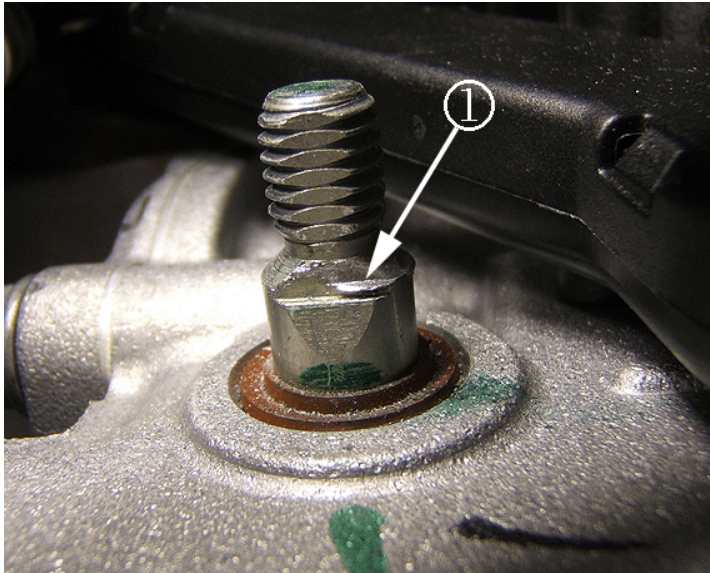
2647515

11. Inspect the flats on both sides of the transmission manual shaft for a burr or metal ridge (1). If a burr exists continue below, otherwise skip to Step 20.

Caution: The following step **MUST** be performed with a flat fine cut metal file **ONLY**. **DO NOT** use a die grinder or any power tool for this operation. Removing excess material beyond the intended described repair may cause excessive play in the transmission manual shaft requiring its replacement.

12. Turn the transmission manual shaft to a position that provides the best access and allows you to place the file as flat to the shaft as possible. A shorter file is desirable due to limited space around the transmission manual shaft

Caution: When performing this operation it is best to remove the burr in several small attempts. The file will quickly remove the burr. Caution must be exercised not to remove too much material creating an undersized condition of the shaft. In all cases, the transmission manual shaft should be made useable by this procedure.

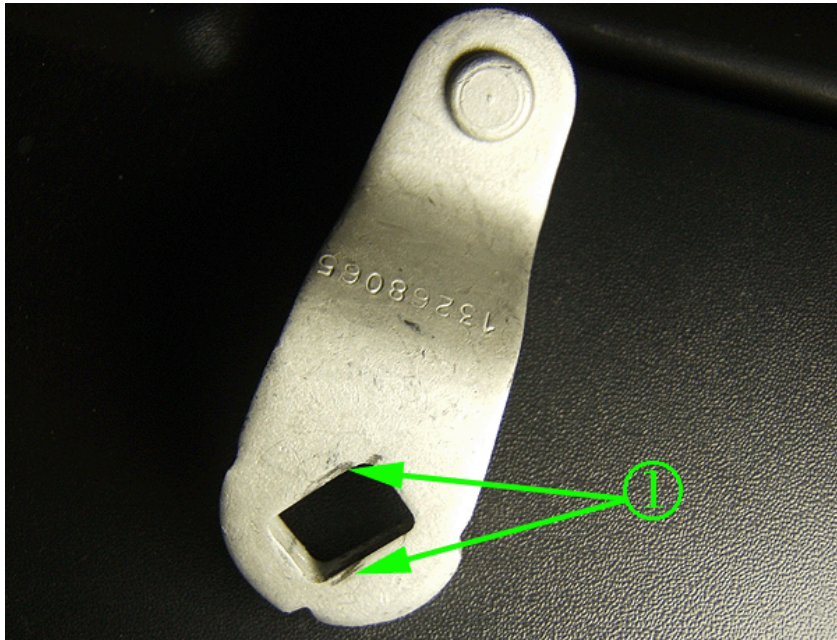
2650633

16. Remove and examine the transmission range selector lever. Confirm that the rectangular receiver in the lever has not been deformed. It is expected that a witness mark (1) on the bottom of the lever may exist (as shown) from contact with the now removed burr. Minor marks at the edge of the receiver will not affect proper operation. Only replace the lever if significant (easily seen) deformation / rounding of the receiver hole exists

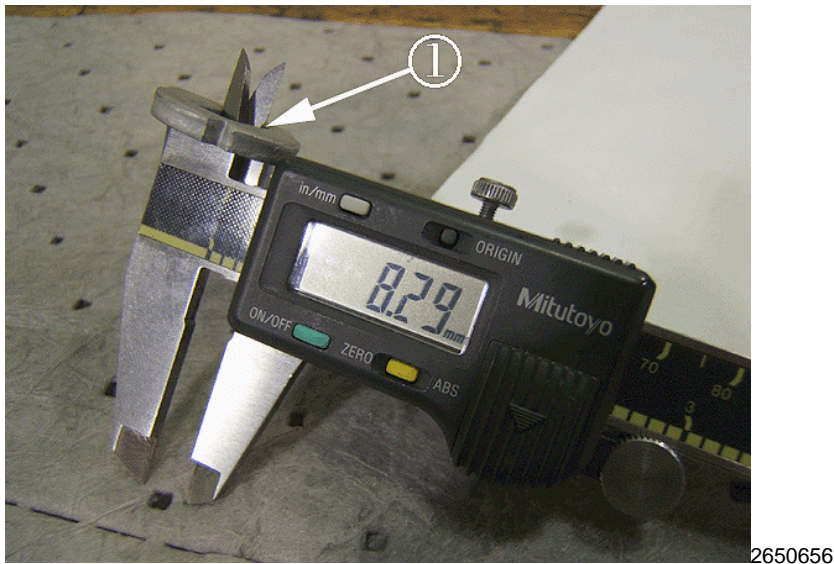
18. Using a caliper, measure the inside of the transmission range selector lever rectangular receiver (1).
19. The difference between the readings across the flats of transmission manual shaft and the inside diameter of the levers mating surface must not be more than 0.2 millimeters or the transmission manual shaft must be replaced.

Example: If the transmission manual shaft measures 8.18mm and the inside diameter of the levers mating surface measures 8.29mm as shown above, the difference is 0.11mm and an acceptable fit.

Caution: IF MEASURED CLEARANCE EXCEEDS 0.2MM, REPLACEMENT OF THE MANUAL SHAFT IS NECESSARY. REFER TO THE "MANUAL SHIFT DETENT LEVER WITH SHAFT POSITION SWITCH ASSEMBLY REPLACEMENT" PROCEDURE IN SI. IF REPLACEMENT IS REQUIRED, SUBMIT REPLACEMENT UNDER NORMAL WARRANTY.
