File In Section: Product Recalls
Bulletin No.: 11142A
Date: May 2011

Recall Bulletin

SUBJECT: Shift Lever May Not Display Correct Gear

MODELS: 2011 Chevrolet Cruze
Equipped with an Automatic Transmission

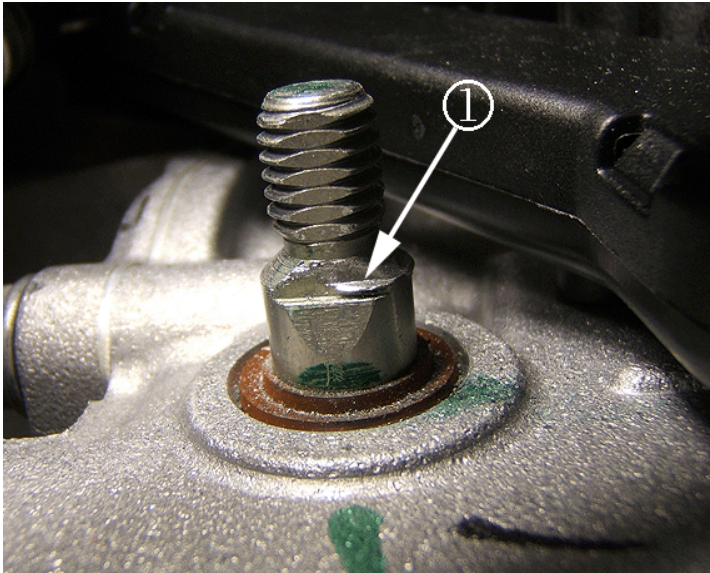
2647515

11. Inspect the flats on both sides of the transmission manual shaft for a burr or metal ridge (1). If a burr exists continue below, otherwise skip to Step 20.

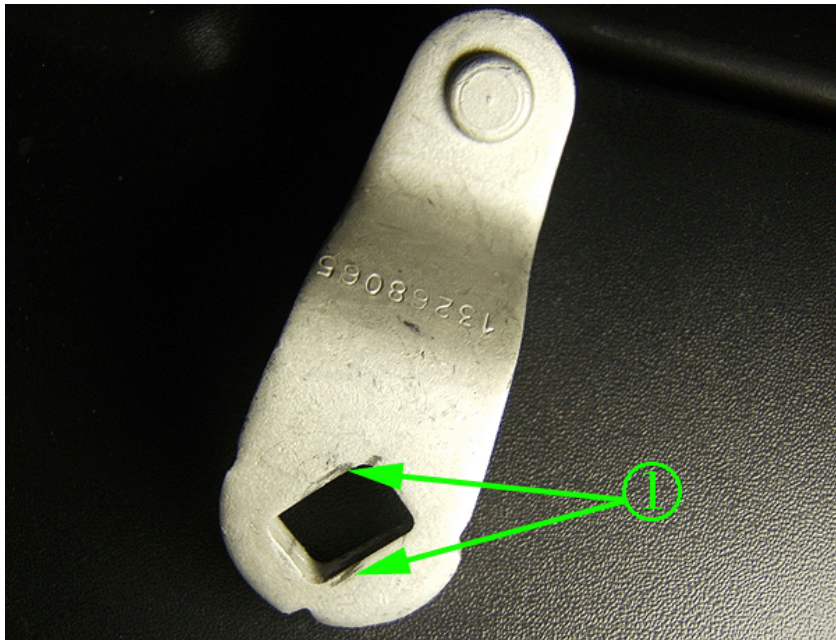
2650633

16. Remove and examine the transmission range selector lever. Confirm that the rectangular receiver in the lever has not been deformed. It is expected that a witness mark (1) on the bottom of the lever may exist (as shown) from contact with the now removed burr. Minor marks at the edge of the receiver will not affect proper operation. Only replace the lever if significant (easily seen) deformation / rounding of the receiver hole exists

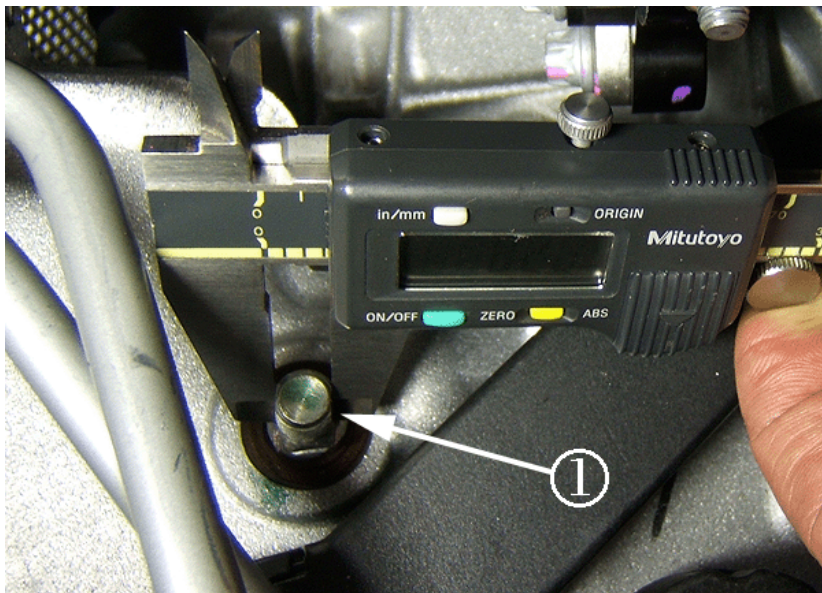
2650652

17. Using a caliper measure the distance across the flats of the transmission manual shaft.

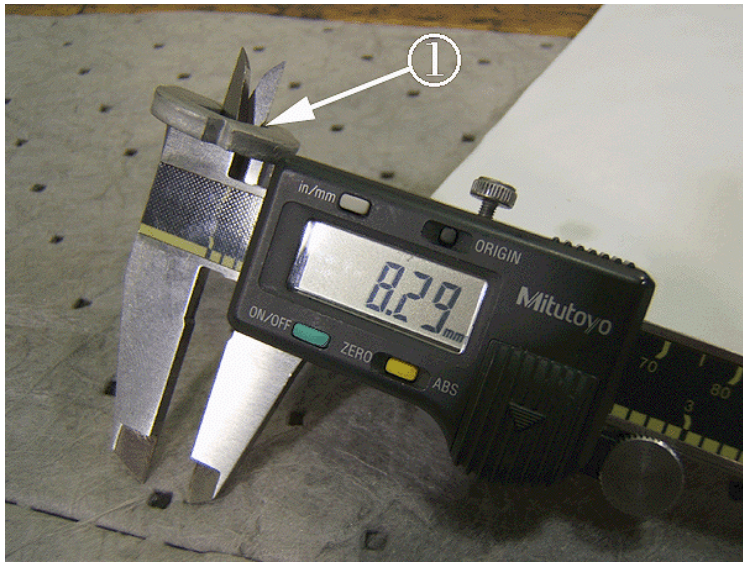
2650656

18. Using a caliper, measure the inside of the transmission range selector lever rectangular receiver (1).
19. The difference between the readings across the flats of transmission manual shaft and the inside diameter of the levers mating surface must not be more than 0.2 millimeters or the transmission manual shaft must be replaced.

Example: If the transmission manual shaft measures 8.18mm and the inside diameter of the levers mating surface measures 8.29mm as shown above, the difference is 0.11mm and an acceptable fit.

Caution: IF MEASURED CLEARANCE EXCEEDS 0.2MM, REPLACEMENT OF THE MANUAL SHAFT IS NECESSARY. REFER TO THE "MANUAL SHIFT DETENT LEVER WITH SHAFT POSITION SWITCH ASSEMBLY REPLACEMENT" PROCEDURE IN SI. IF REPLACEMENT IS REQUIRED, SUBMIT REPLACEMENT UNDER NORMAL WARRANTY.
