# TECHNICAL SERVICE BULLETIN

V-11-01

V-11-01A

### SUBJECT: 2011 Cross Country Handlebar Riser Assembly Inspection / Replacement

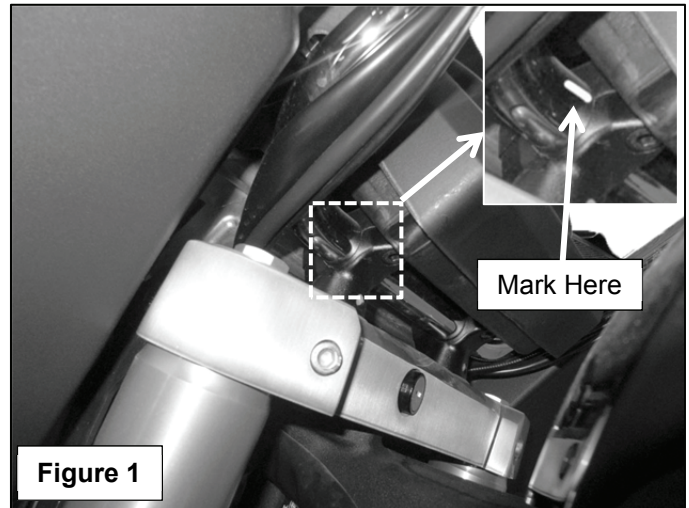
2. Using a grease pen, mark the handlebar at the parting line between the riser and riser clamp (see Figure 1). The mark will be used to determine if any handlebar rotation has occurred following the inspection.

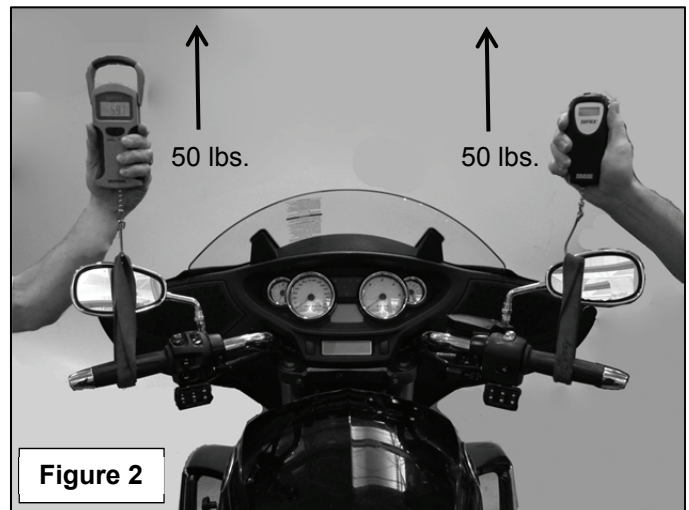
3. Securely attach tie straps around center of left and right handgrips (see Figure 2).

4. Attach the spring scales to the tie straps (see Figure 2).

5. With one person on each side of the motorcycle, slowly apply an upward (vertical lifting) force until each scale individually reads 50 lbs. (Force totaling 100 lbs. on the handlebar assembly).

**THE HANDLEBAR ASSEMBLY SHOULD NOT ROTATE WITHIN THE RISERS. IF ANY MOVEMENT IS DETECTED THE RISER / CLAMP ASSEMBLIES MUST BE REPLACED (PROCEED TO REPLACEMENT PROCEDURE).**
