Bulletin Number: 11-0236

Service Bulletin

SAFETY RECALL

2010-2011 VT750C/C2B Bank Angle Sensor Replacement

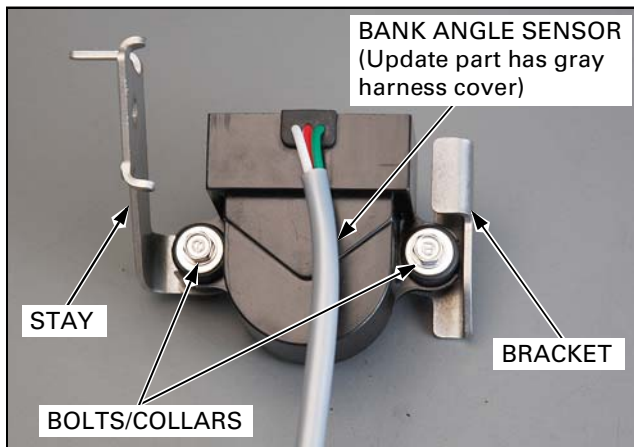
On affected motorcycles, normal engine vibration can create a resonance in the bank angle sensor that, under certain conditions, can cause it to malfunction and shut off the engine even though the motorcycle has not fallen onto its side.

8. Remove the bolts, collars and bank angle sensor from the stay and bracket.
Install the updated bank angle sensor to the stay and bracket as shown.
Install the collars, bolts and tighten the bolts securely.

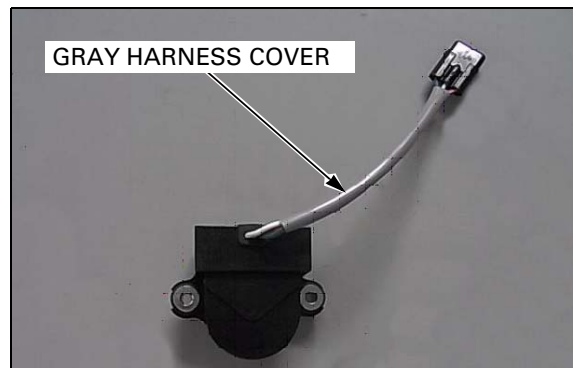
The update part has a gray harness cover.
