Campaign No. 2011100006, November 2011

SUBJECT: **Model 906, Model Year 2011**  
**Check Rear Springs, Replace if Necessary**

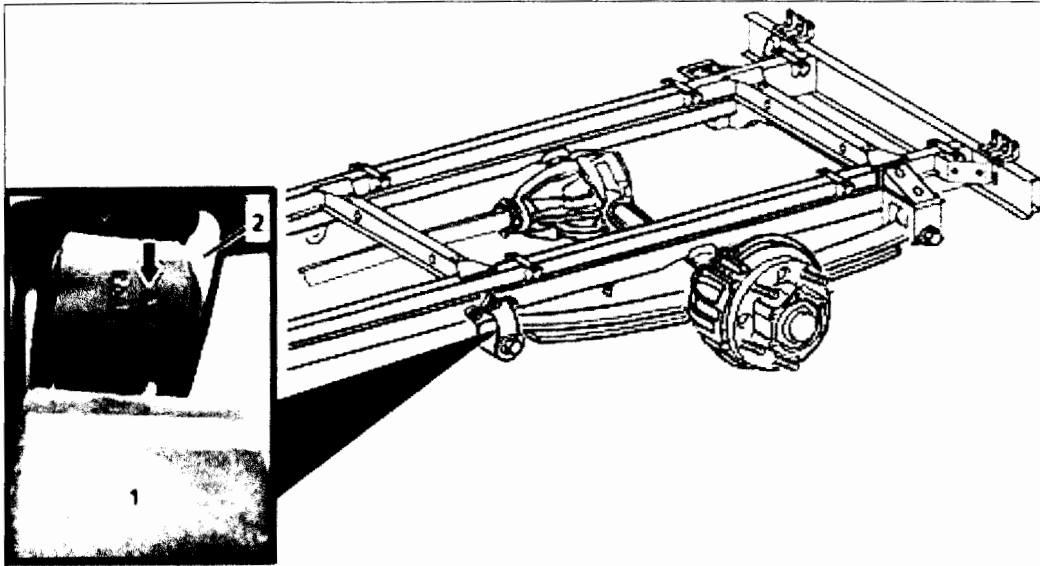
Figure 1

This Recall Campaign has been initiated because Daimler AG (DAG) has determined that on certain Sprinter vehicles, the rear springs may not meet the material standards requirements. The supplier rolled the spring eye out of tolerance on a limited number of parts in its production. In order to correct the diameter of the spring eye, the supplier pressed these springs under cold conditions. As a result, this may have caused hydrogen embrittlement within the material which could potentially lead to a crack of the spring eye over time. This could lead to an increased risk of a crash. DVUSA therefore has initiated a recall of all potentially affected vehicles described above. An authorized Freightliner or Mercedes-Benz Sprinter dealer will remedy this condition by checking an identification mark on the rear springs and replacing the rear springs if necessary.

1. Check if batch number (arrow, Figure 1) is stamped on top of the front mounting eye (1, Figure 1) of rear axle spring using a mirror (2) then repeat inspection on opposite side:
  - If batch number stamped on **either the left or right** spring is **NOT**: SIAAA7 (on none of the springs), Procedure is complete.
  - If batch number stamped on **either the left or right** spring is: SIAAA7 (on one of the springs) proceed to step 2.
2. Replace **both** rear springs; refer to WIS; AR32.20-D-0230H.
