TECHNICAL SERVICE BULLETIN

Indian Motorcycle

Bulletin Number: I-11-01
Model Year(s): 2009-2011

SUBJECT: 2009-2011 Indian Motorcycles (all models) Body Control Module Replacement

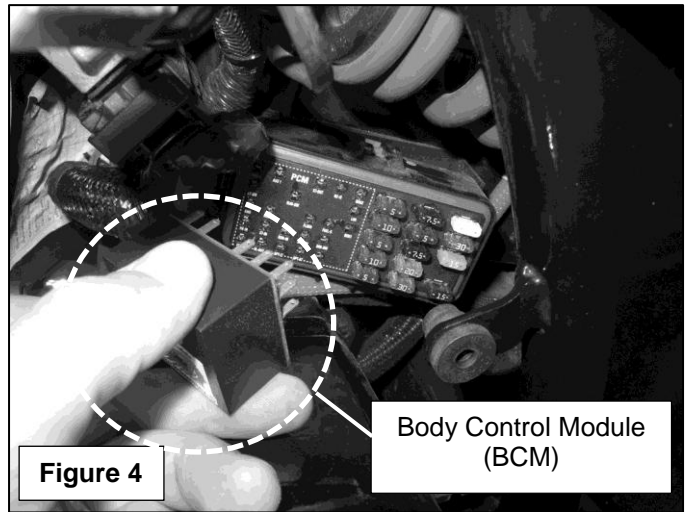
Indian Motorcycle has determined that some motorcycles produced between 12/10/2008 and 04/08/2011 may have been manufactured using a defective Body Control Module (BCM). Affected units may lose headlamp function when switching between high-beam and low-beam modes. Headlamps will remain inoperable until ignition is switched off and then back on again. The loss of headlamp function may increase the risk of an operator losing control which could result in a vehicle crash.

4. Remove old BCM and install replacement BCM (see Figure 4).
5. Install Service Bulletin Completion Decal (see page 4).
