RE: Safety Defect and Noncompliance Report for Vehicles, IAW 49 CFR Part 573

SAFETY DEFECT AND NONCOMPLIANCE REPORT

SAFETY RECALL SR 11-001A

Steering Shaft Splined Yoke Inspection and Replacement

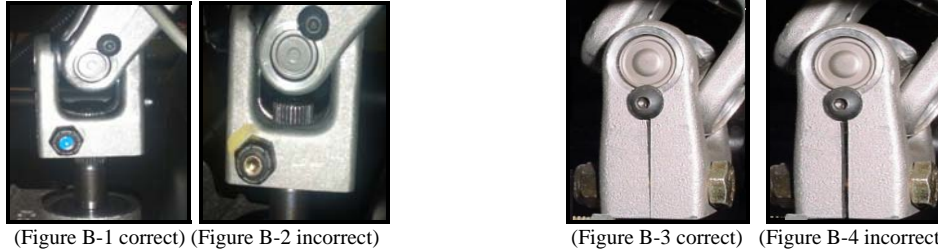
- A) Possible loosening of lower steering yoke, at point of attachment to steering rack pinion, causing spine teeth to strip, which results in slippage of yoke at pinion gear.
- B) Determined cause of defect: Yoke positioning and retaining bolt tightening processes may not have been consistently followed during production, leading to potential inadequate spline coverage and tension at lower steering yoke.

Figure B-1 indicates correct position between steering yoke bottom and steering rack.

Figure B-2 indicates steering yoke mounted too low on steering rack pinion shaft.

Figure B-3 indicates steering yoke bolt properly torqued and compressed.

Figure B-4 indicates steering yoke bolt is not properly torqued or compressed.

1. Inspection of position where steering yoke is fastened to steering rack pinion gear. Clearance between lowest portion of yoke and top of steering rack must be between 15/16" and 1-1/16" inch. If not, lower yoke must be replaced.
2. Measurement of torque on lower steering yoke retaining bolt. This bolt must be a verified grade 8 bolt and properly torqued to 25 ft lbs. If not, lower yoke must be replaced.
3. If position of lower yoke is correct as shown in item 1, and the bolt is properly torqued to 25 ft lbs, no further action is required.

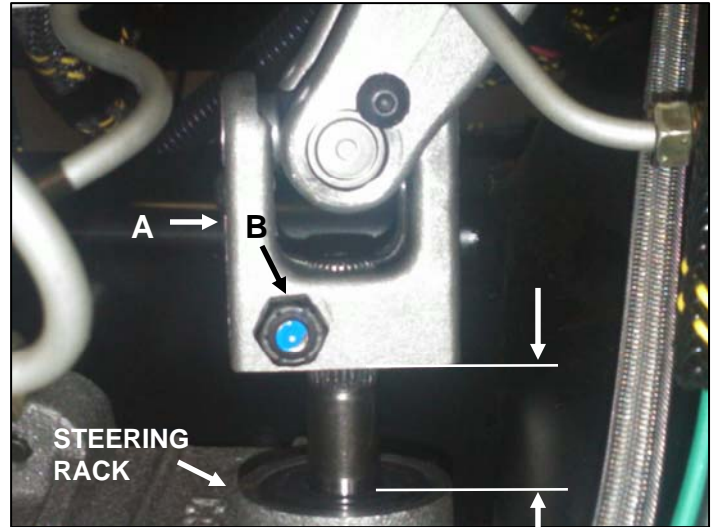
Figure 4 (A,B,C)

1. See Figure 4. Measure the distance between the bottom of the lower splined yoke (Figure 4A) and the top of the steering rack (Figure 4C). This measurement is to be between 15/16" and 1-1/16".

2. If the distance between the bottom of the lower splined yoke and the top of the steering rack is not between 15/16" and 1-1/16" or if the yoke retaining bolt (Figure 4B) torque was found below 25 ft lbs the lower steering yoke must be replaced.

If this space is between 15/16" and 1-1/16" inspect the torque of the yoke retaining bolt (Figure 4B).

8. With the lower splined yoke properly placed, torque the yoke retaining bolt (Figure 4B) to 25 ft lbs.
