## CERTAIN 2011 MODEL YEAR RANGER VEHICLES BUILT WITH A SUSPECT MULTIFUNCTION SWITCH AND CERTAIN VEHICLES SERVICED WITH A SUSPECT MULTIFUNCTION SWITCH — MULTIFUNCTION SWITCH INSPECTION AND REPLACEMENT

### OVERVIEW

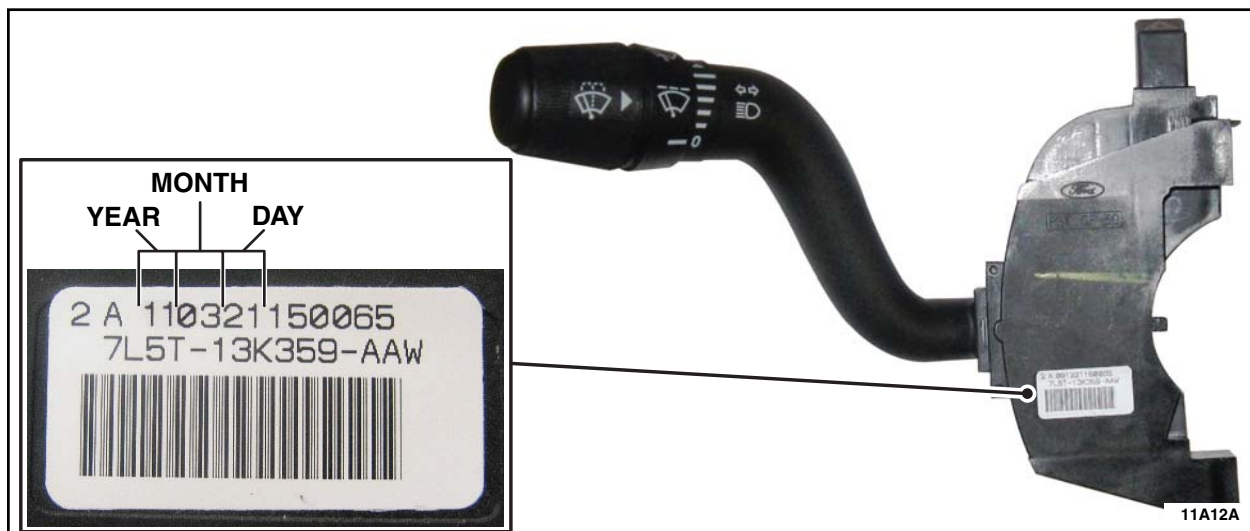
FIGURE 1

This program involves the inspection of the date code on the multifunction switch. The switch must be replaced if it was built January 12, 2011 through April 9, 2011.

1. If equipped, remove the steering column tilt release lever/ handle.
2. Remove the 3 steering column shroud screws and position back the upper and lower steering column shrouds to access the 2 multifunction switch retaining screws.
3. Remove the 2 multifunction switch screws and position the switch away from the steering column so that the bar code label is visible.
  - To install, tighten to 3 Nm (27 lb-in).
4. Inspect the date code on the bar code label. See Figure 1.

- If the date code on the bar code label is January 12, 2011 (110112) through April 9, 2011 (110409), disconnect the electrical connectors and **replace** the multifunction switch. Proceed to step 6.
- If the date code is before January 12, 2011 or after April 9, 2011, **do not replace** the multifunction switch. Reassemble and return the vehicle to the owner.
