## FUSE BOX CONNECTIONS • INSPECT AND TORQUE TIGHTEN 9700 (B13R)

### MODEL YEAR(S) AND VEHICLES INVOLVED

Model Year 2009 to 2011 incl.	From chassis 127142 up to 148659 incl.
----------------------------------	--

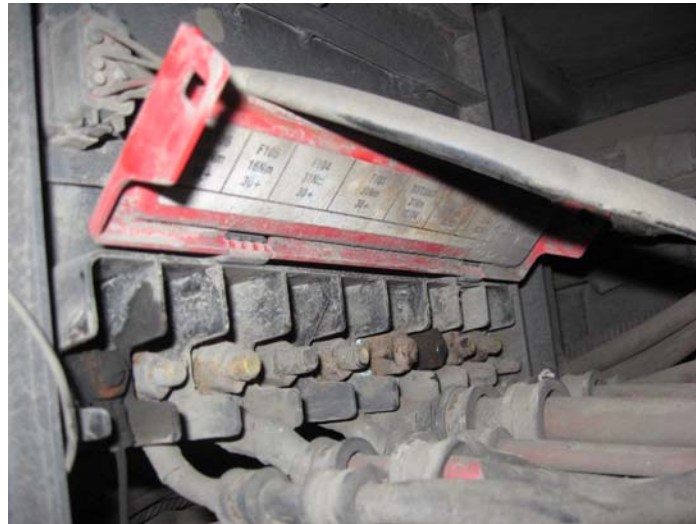
On the vehicles affected by this bulletin, there is a possibility of poorly tightened nuts on the front and rear fuse boxes connections. Symptoms could be poor A/C performance or bad startability. In worst case, this could lead to bad contact, excessive heat development or a fire.

2. Check for any damages, inspect and torque tighten all cable connections on front fuse box. See method below. Check also clamping to the bracket of all connected cables and remedy when necessary.
