SERVICE PROCEDURE

**G-11513
SEPTEMBER 2011**

**SUBJECT: SAFETY RECALL
DUAL RISER PASSENGER SEAT on certain CE and
RE model school buses built 10/8/09 thru 4/14/11
with passenger seat feature code 48USV, 48SRA,
or 48SWA**

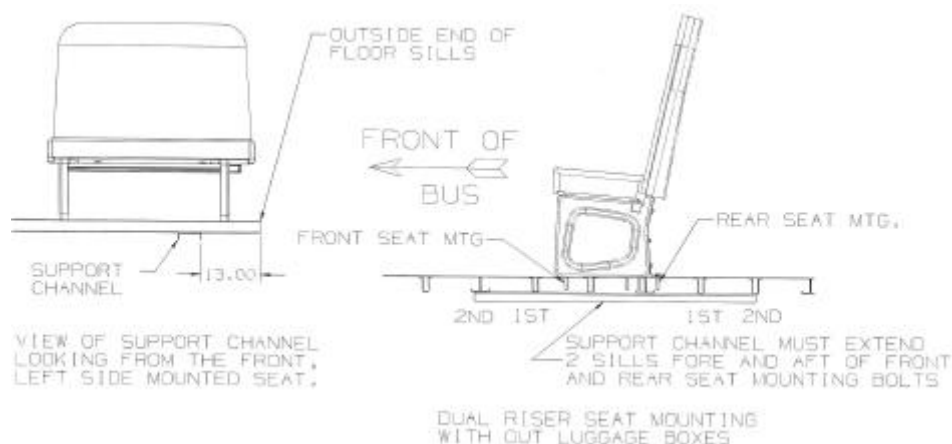
The unit you are inspecting may be missing or have an improperly installed support channel under the floor for the subject seat. The inspection is to determine if a support channel running fore and aft starts at least two floor sills in front of the dual riser front mounting hardware and extending to at least two floor sills to the rear of the dual riser seat rear mounting hardware was attached to the underside of the floor sills. See following diagram for required support location.

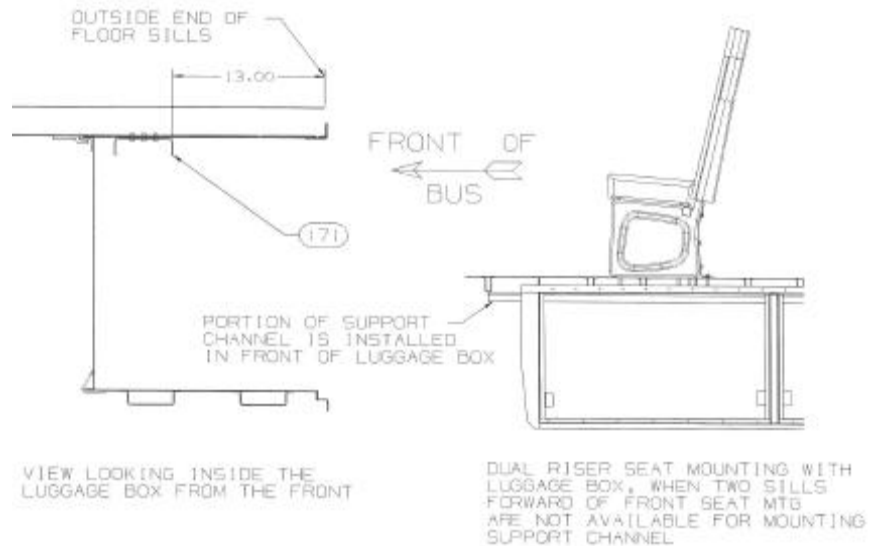
Units with non pass through luggage boxes will have all or portion of the support channel attached to the ceiling inside the box. Units with pass through luggage boxes will have all or portion of the support channel attached to the underside of the floor sills inside the box. In some cases portion of the channel was cut and was attached to the underside of the floor sills in front of the box based on the location of the box with the dual riser seat and additional luggage boxes if any. See following diagram for required support location.
