Clutch Pedal Safety Recall
CHU, CXU, GU

Clutch Pedal Safety Recall SC0355

(August 2011)

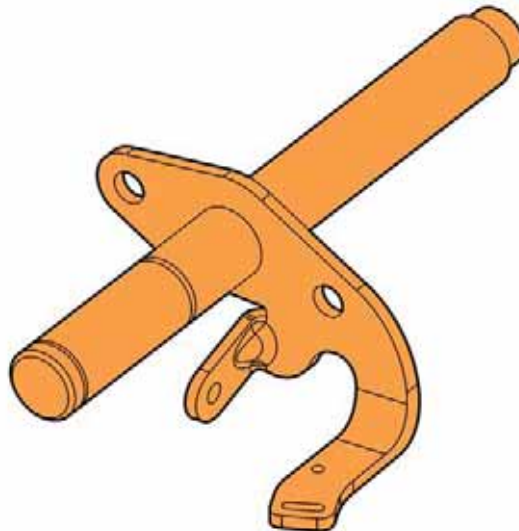
Clutch shaft and bracket assembly 82280756
