# Safety Recall Trucks

| Date | Group. | No. | Page |
|---|---|---|---|
| 08/29/11 | | <b>SC0355</b> | 1(8) |

Clutch Pedal Safety Recall  
CHU, CXU, GU

## Clutch Pedal Safety Recall SC0355

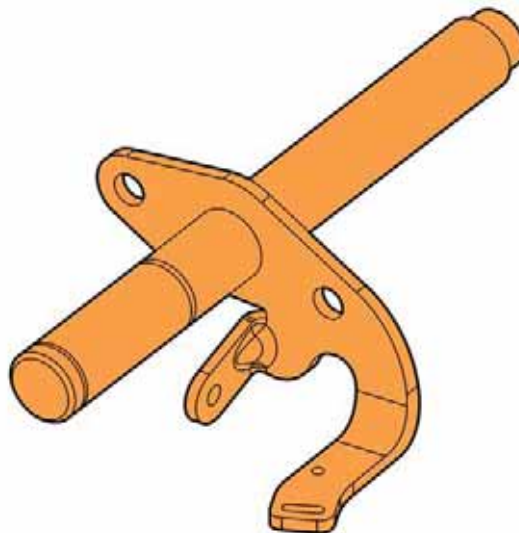
MACK has identified a potential safety related defect in the clutch pedal shaft assembly on CHU, CXU, and GU model trucks. These trucks may have been built or repaired with a clutch pedal shaft assembly containing improper welds. The improper weld is located between the clutch pedal stop flange bracket and the clutch pedal shaft. If the weld fails, the pedal's shaft may work its way loose and potentially cause the clutch pedal to fall to the floor which could result in a vehicle crash.

Clutch shaft and bracket assembly 82280756
