RECALL CAMPAIGN BULLETIN

NTB11-067

VOLUNTARY SAFETY RECALL CAMPAIGN 2011 – 2012 ALTIMA FRONT TRANSVERSE LINK BOLTS

CAMPAIGN ID #: PC099

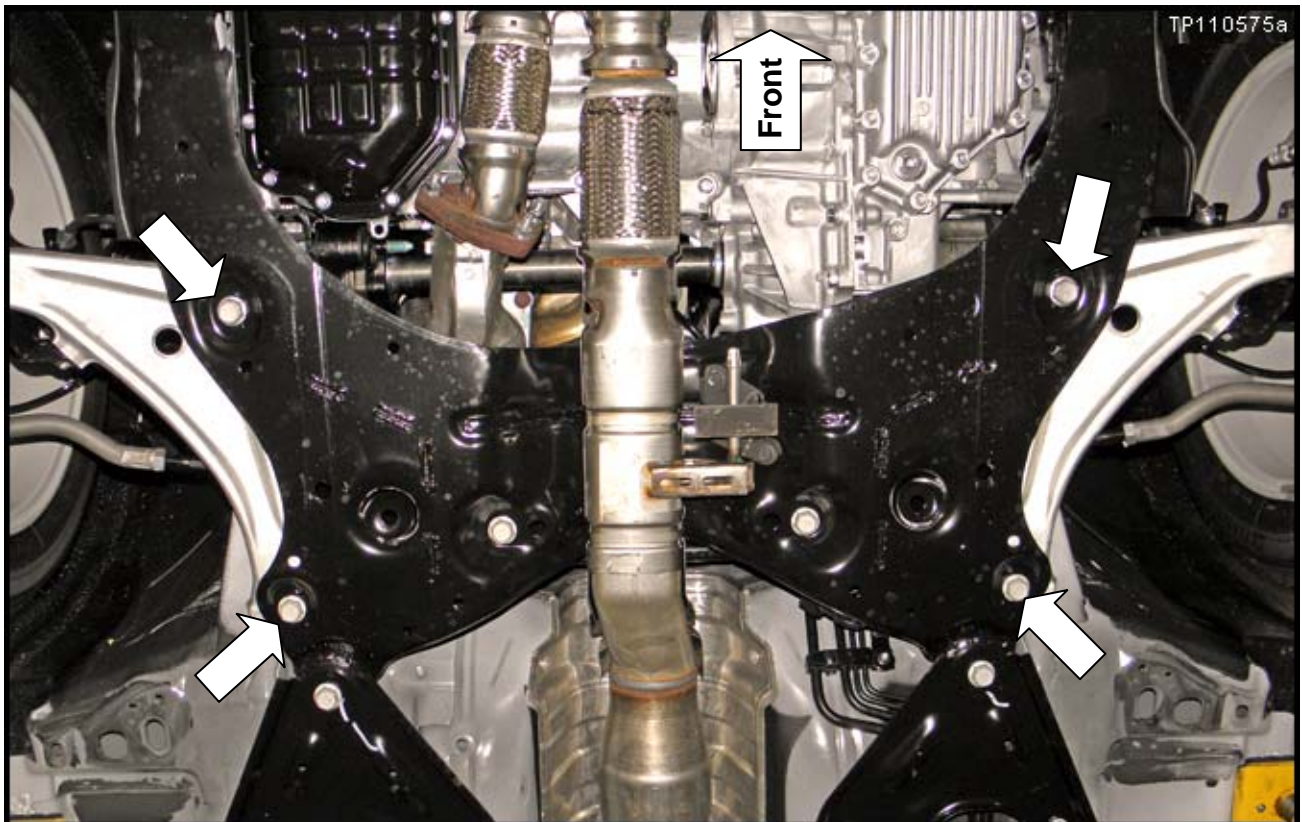
Figure 1

1. Lift the vehicle on a hoist.
2. Locate the front transverse link bolts (see Figure 1).
