**\*\*\*\*\* IMPORTANT VEHICLE RECALL NOTICE \*\*\*\*\***

RE: Volvo Recall 246  
Certain Model Year 2007 S80 6 Cylinder Non-Turbo Vehicles

<b>Volvo Car Customer Service</b>	
TJ Instruction	
TJ 25040	
July-2011 Issue 01	
<b>Recall 246, Power Steering Return Hose</b>

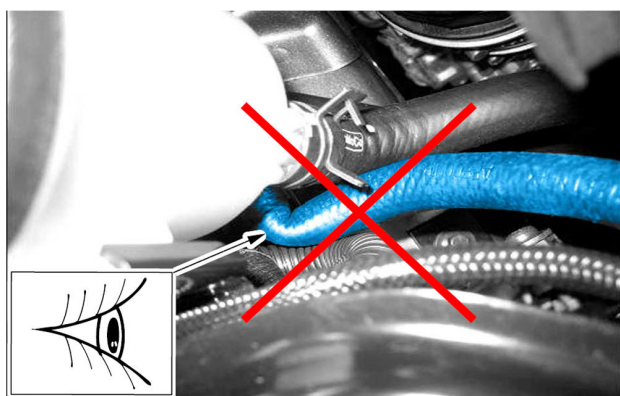
The power steering reservoir return hose may have been incorrectly routed, which can result in increased pressure in the power steering system. The power steering return hose may burst at the steering gear due to the increased pressure, resulting in a loss of power steering fluid and a sudden loss of power steering assistance without prior warning to the driver.

This hose is incorrectly routed.  
A restriction can be seen.  
The repairs specified in the TJ  
should be carried out.

The corrective action will be to inspect the routing of the power steering reservoir return hose according to the attached document . If the reservoir return hose is routed correctly, no further action is required. If the reservoir return hose is routed incorrectly, it will be necessary to replace and re-route the reservoir return hose, and also replace the steering gear return hose and the power steering fluid reservoir.

- Power steering reservoir, 30680756
- Power steering return hose (from cooling coil to steering gear), 31360018
- Power steering cooling coil (return hose at reservoir), 31329150

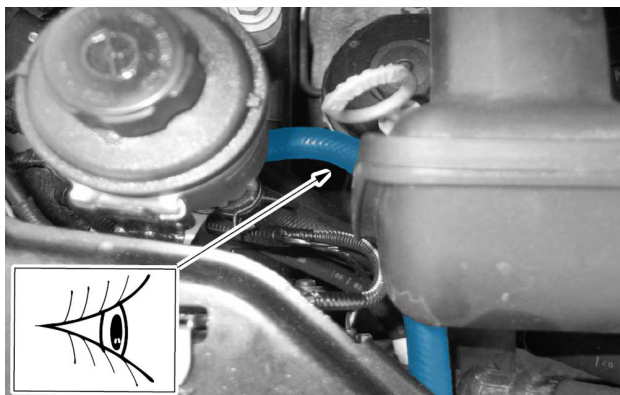
This hose is correctly routed.  
There is no restriction.  
No further action needs to be  
taken.
