Service Bulletin No. 362

MODEL E / J Series Coaches	TYPE Field Change Program	SECTION/GROUP 7-Electrical	DATE
SUBJECT DOGA WINDSHIELD WIPER MOTOR FUSE			
CONDITIONS

Ref. NHTSA Recall No.: 11V-

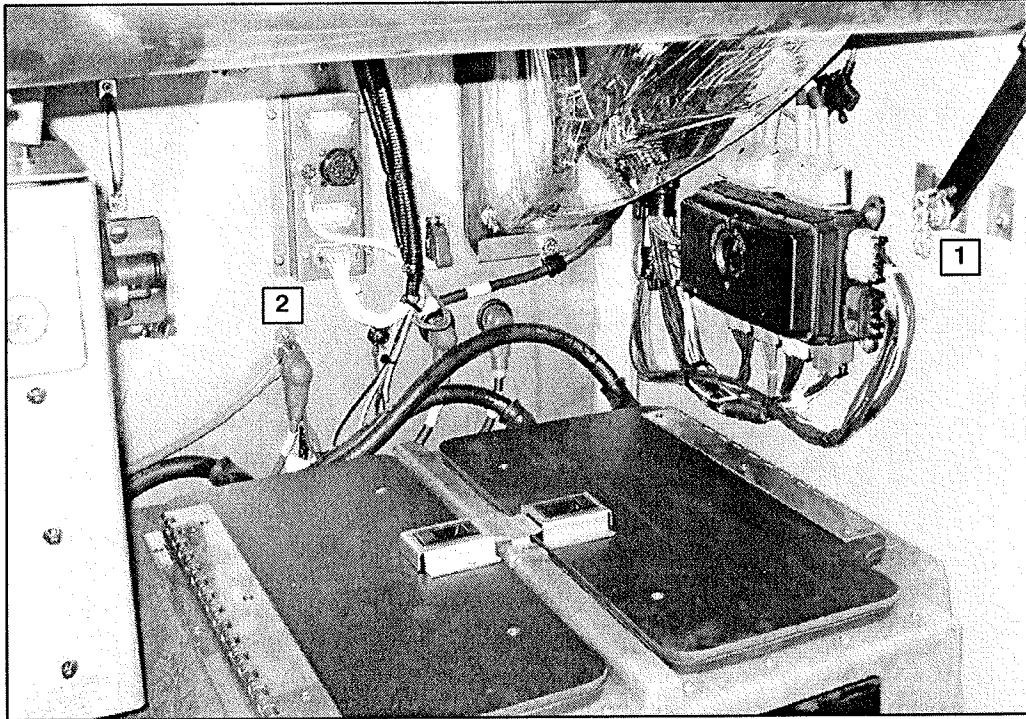
Figure 1.

1. Open the battery compartment door. Install the positive lock pin in the hole of the hinge to secure the door in the open position (refer to Figure 1).
2. Activate the disconnect feature of the main battery disconnect (MDS) system by pressing (for one second only) the momentary toggle switch on the MDS module to OFF. An audible click can be heard from the main solenoids in the MDS module. Position the rotary switch to the DOWN (OFF) position.
3. Chock both sides of the tires.

4. Locate the 24V HOT power stud block on the back compartment wall (refer to Figure 1).

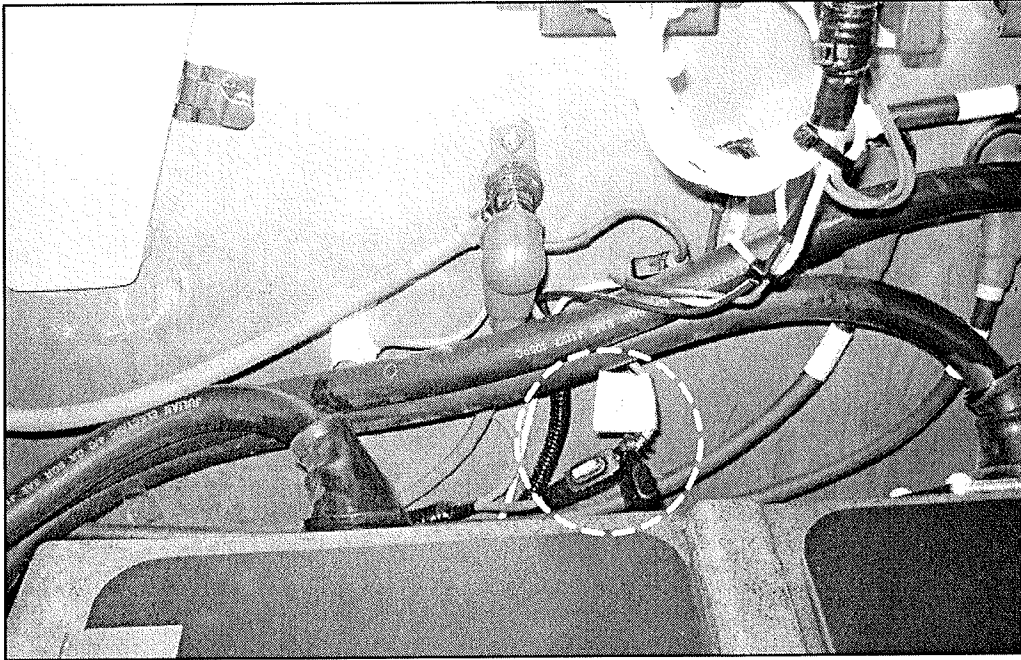
Figure 2.

5. Locate the inline fuse routed from the 24V HOT power stud block with the decal labelled either FUSE5 15A MAX, or 30A MAX. BATT HOT (refer to Figure 2).

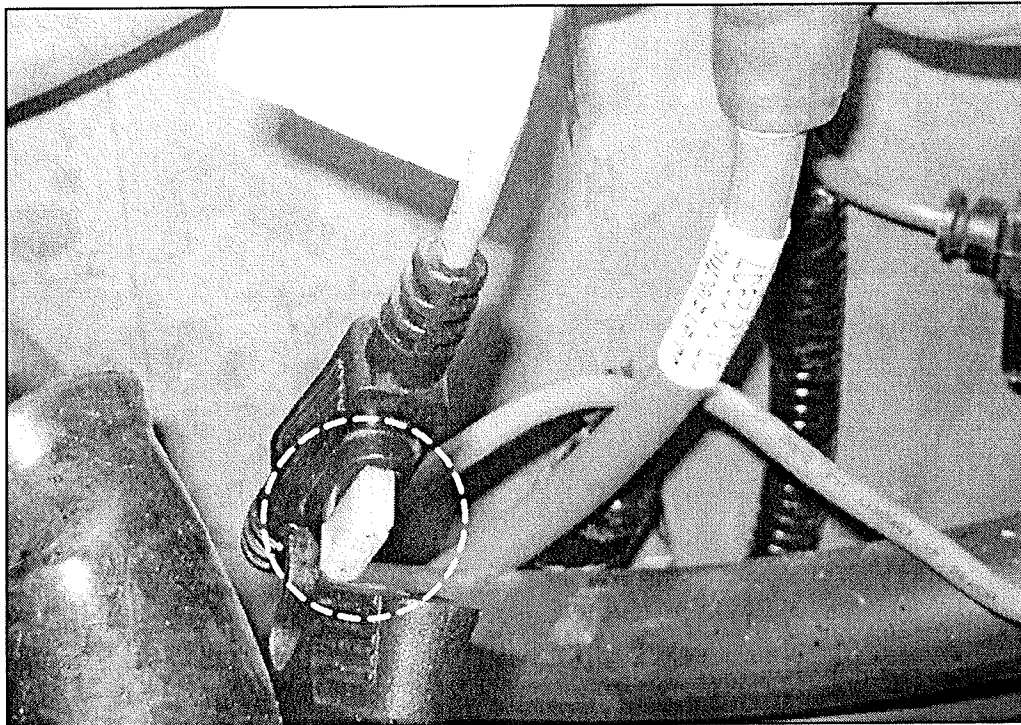
Figure 3.

6. Remove the protective flip – cap. Visually inspect to verify that a 30 AMP fuse is installed (refer to Figure 3).

If a 30 AMP fuse is installed, press to secure the flip–cap over the fuse. Visually inspect to verify that the decal text is 30A MAX BATT HOT. If not, install a new 30A decal, p/n 07-08-4061. Close the battery compartment door. Procedure complete.

If a 15 AMP fuse is installed, carefully remove the 15 AMP fuse and install a 30 AMP fuse, p/n 07-08-2176. Press to secure the flip–cap over the 30 AMP fuse. Remove the existing 15A decal and install a new 30A decal, p/n 07-08-4061. Close the battery compartment door. Procedure complete.
