Audi

Safety Recall

Code: 20Q8

Subject: 2011 – 2012 model year Audi R8 Spyder
Fuel Supply Line

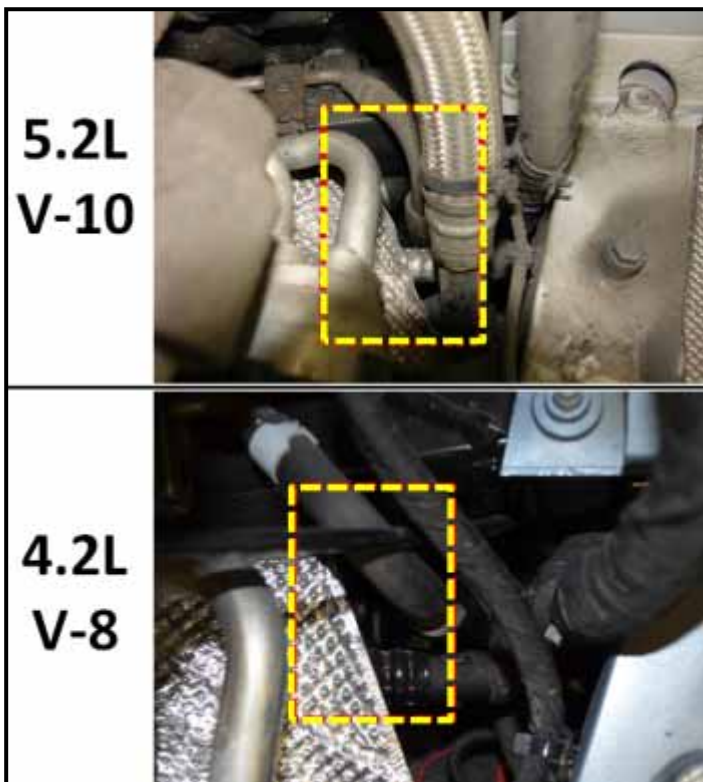
⇐ Identify area for visual inspection <rectangle>

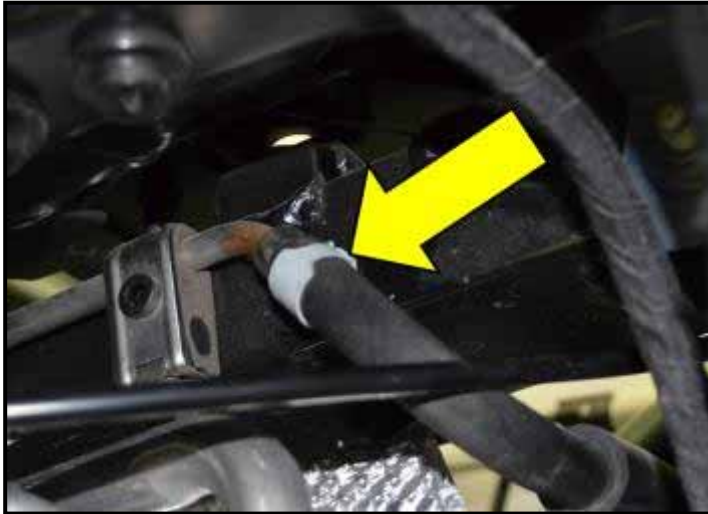
⇐ Remove spring clip <arrow> and remove rubber portion of damaged fuel line from vehicle

⇐ Install new rubber fuel line onto existing steel fuel line and secure spring clip <arrow> properly into position

! Note: DO NOT use any lubricant to install rubber line
