PRODUCT SAFETY RECALL

SUBJECT: Power Steering Hose Routed Incorrectly

MODELS: 2012 Chevrolet Impala

GM Recall #11224

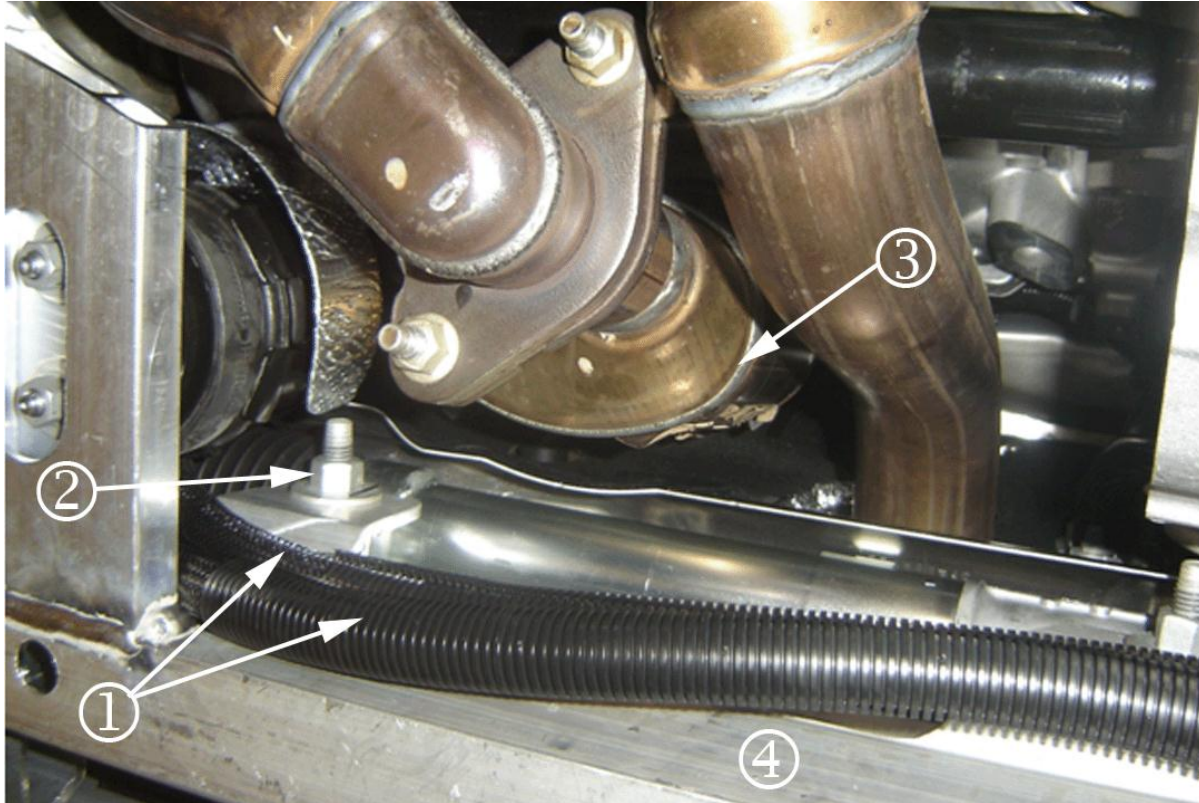
2696264

Correctly Routed Power Steering Gear Inlet Pipe/Hoses are Routed Below the Steering Gear Mount Bolt: (1) Power Steering Gear Inlet Pipe/Hose (2) Steering Gear Mount Bolt (3) Catalytic Converter (4) Cradle

- If the power steering gear inlet pipe/hoses are routed correctly, proceed to *Protective Sleeve Installation* in this bulletin.

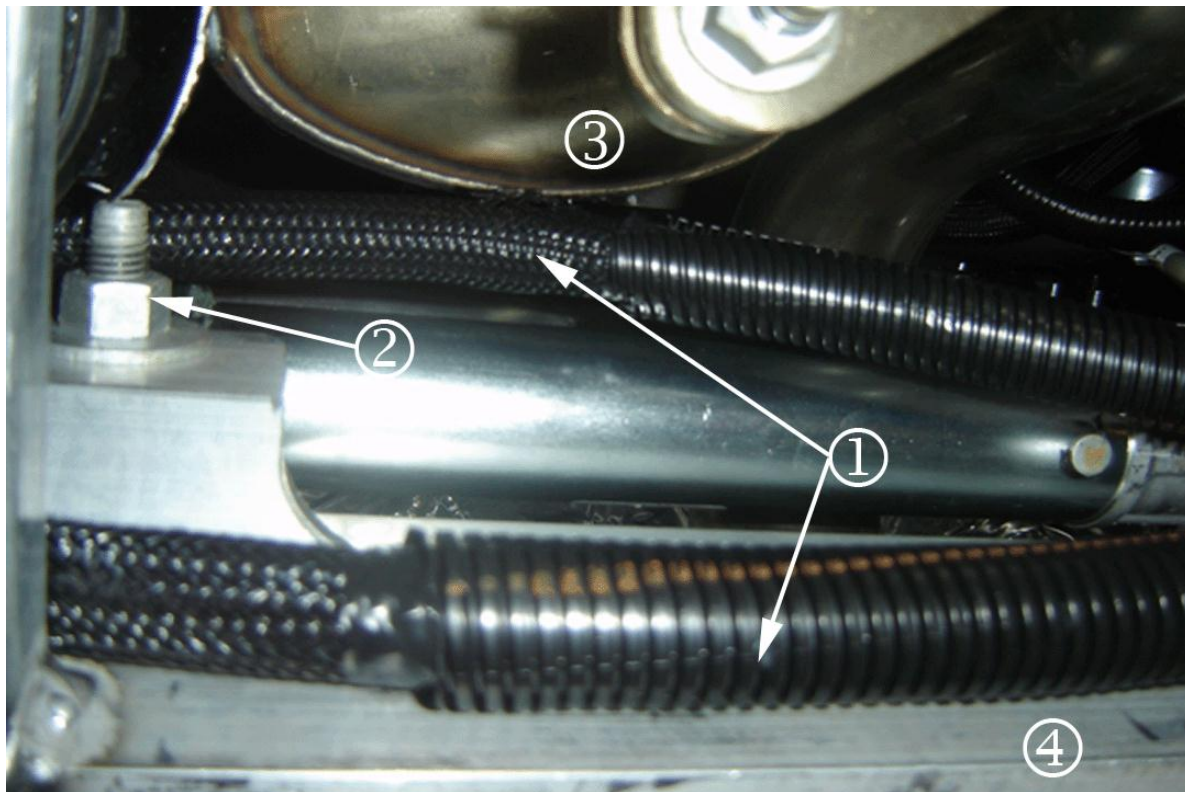
2696265

Incorrectly Routed Power Steering Gear Inlet Pipe/Hoses are Routed Above the Steering Gear Mount Bolt: (1) Power Steering Gear Inlet Pipe/Hose (2) Steering Gear Mount Bolt (3) Catalytic Converter (4) Cradle

Note: Incorrectly routed power steering gear inlet pipe/hoses include one or both hoses routed above the steering gear bolt. The hoses may contact the steering gear bolt and/or the catalytic converter. **REPLACE** the power steering gear inlet pipe/hoses if the hoses are incorrectly routed.

- If the power steering gear inlet pipe/hoses are NOT routed correctly, remove and replace the power steering gear inlet/pipe hoses. Refer to *Power Steering Gear Inlet Pipe/Hose Replacement* in SI. After installing the power steering gear inlet pipe/hoses, ensure that the hoses are routed below the steering gear mount bolt. Refer to *Correctly Routed Power Steering Gear Inlet Pipe/Hose* illustration. Proceed to *Protective Sleeve Installation* in this bulletin after installing the power steering gear inlet pipe/hoses.

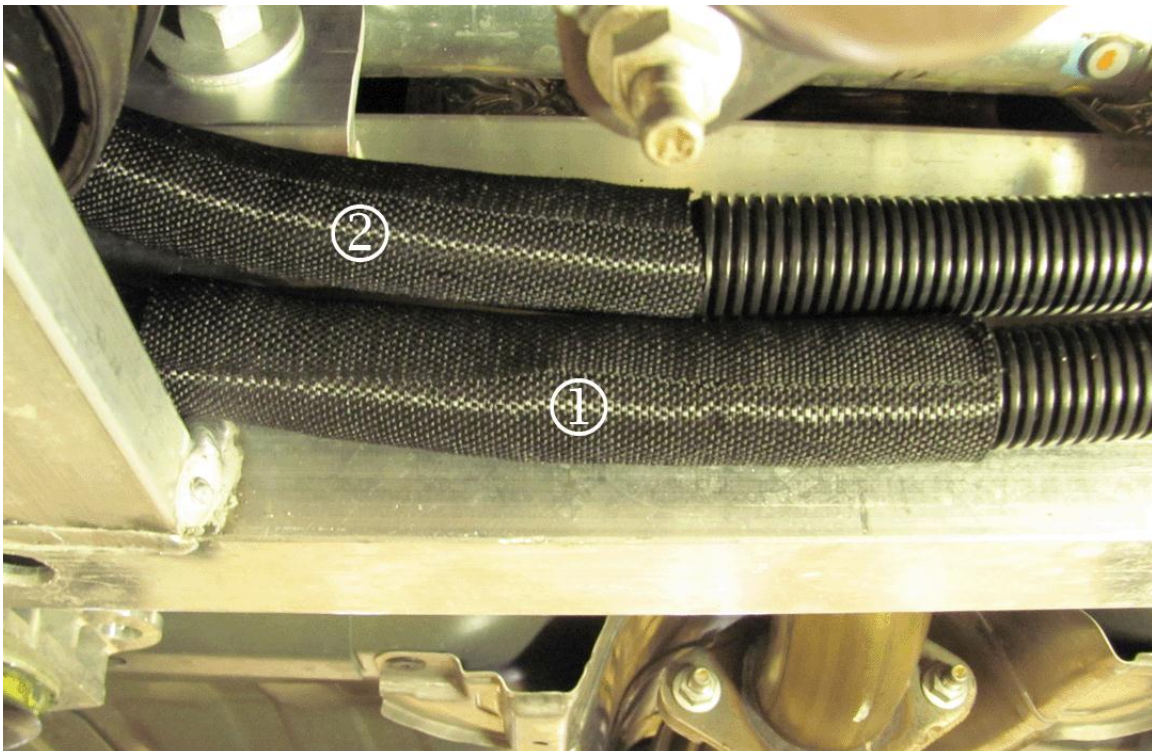
2697638

Note: The purpose of the protective sleeves on the lower hoses is to protect the hose from the edge of the cradle side rail.

2. Place the first piece of protective sleeve on the lower hose (1).

3. Place the second piece of protective sleeve on the lower hose (1).
 - 3.1 Begin wrapping the protective sleeves around the hard plastic conduit portion of the hose.
 - 3.2 Slide both protective sleeves toward the passenger side of the vehicle. The protective sleeve should end adjacent to the hard plastic conduit. The protective sleeve should NOT overlap the hard plastic conduit portion of the hose.
 - 3.3 Ensure that the overlapping edges of the protective sleeves are facing down and away from the cradle.
