INSTRUCTION TO SERVICE ITS: 4740

SECTION: 219 Engine & Transmission	MODEL: <input type="checkbox"/> 30FT <input type="checkbox"/> 35FT <input checked="" type="checkbox"/> 40FT <input type="checkbox"/> 60FT <input checked="" type="checkbox"/> GSL <input type="checkbox"/> CNG <input type="checkbox"/> LNG <input checked="" type="checkbox"/> ELEC	TYPE: <input type="checkbox"/> HIGH FLOOR <input checked="" type="checkbox"/> LOW FLOOR	WRITTEN BY: Grant Li
---	--	---	-----------------------------

OBJECTIVE/SUBJECT:
Replace gearbox output flange bolts.

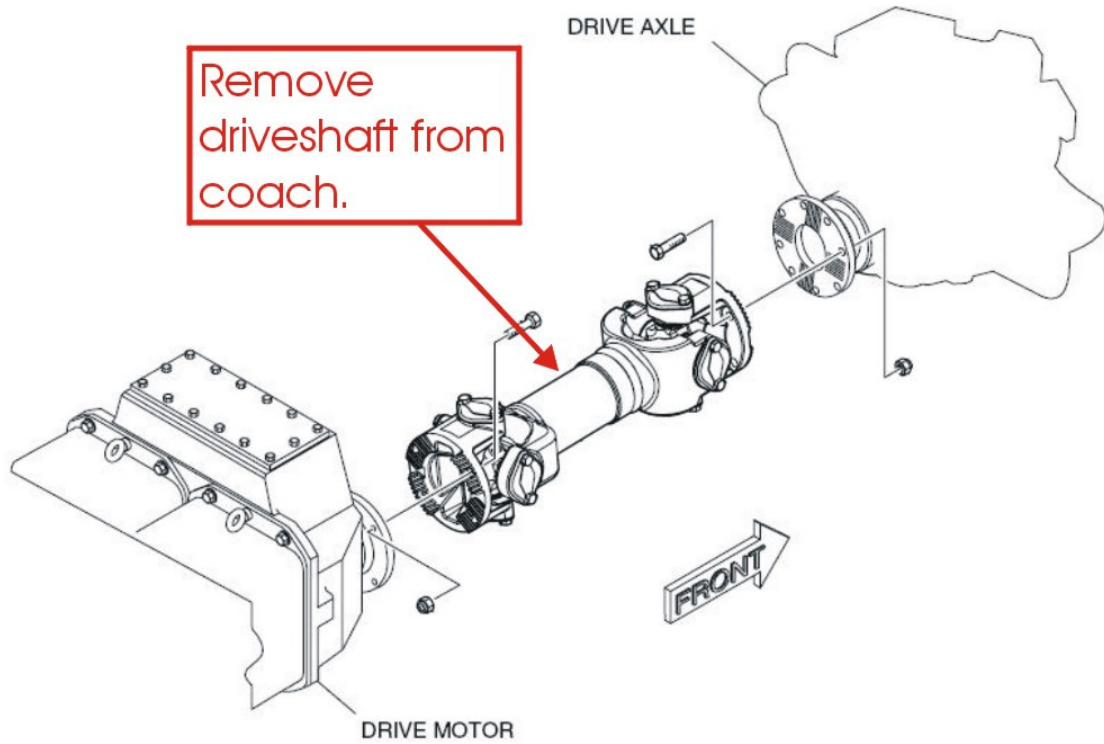
Figure 1: Driveshaft installation.

- PROCEDURE:**
1. Turn the main battery disconnect switch to the "OFF" position.
 2. Raise coach in accordance with the New Flyer Service Manual.
 3. Remove driveshaft from the bus. Retain bolts for reuse, discard locknuts. See Figure 1.

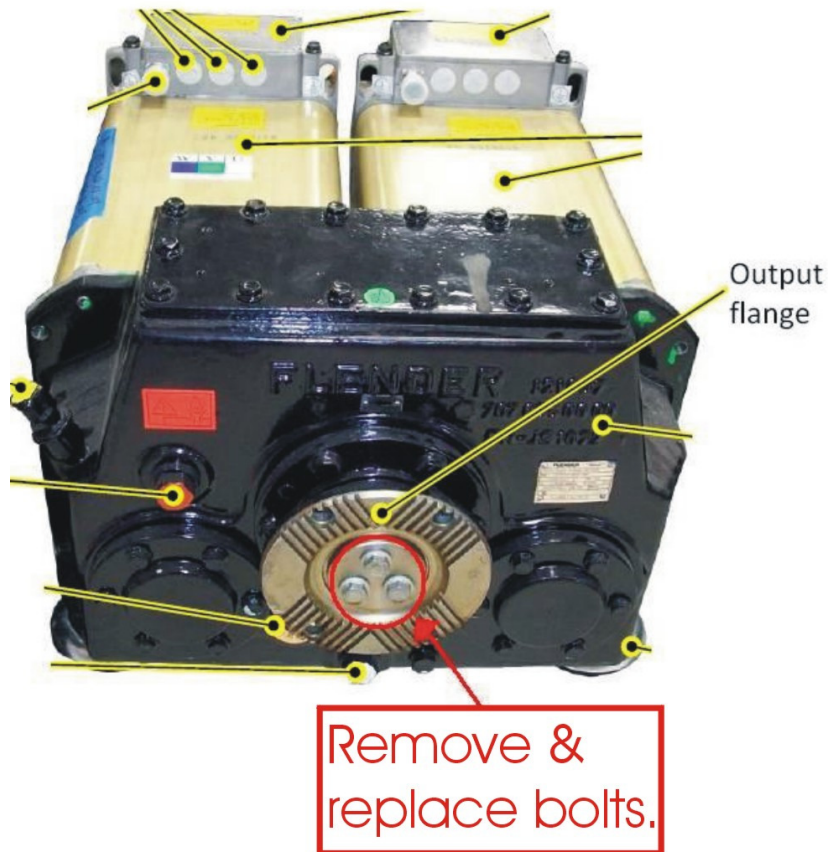
Figure 2:

4. Inspect hardware shown in Figure 2 for looseness and note results.

5. Remove hardware from gearbox flange as shown in Figure 2 and discard.
6. Inspect endplate (PN 6403697), ensure it is not warped, replace if damaged. See Figure 3.

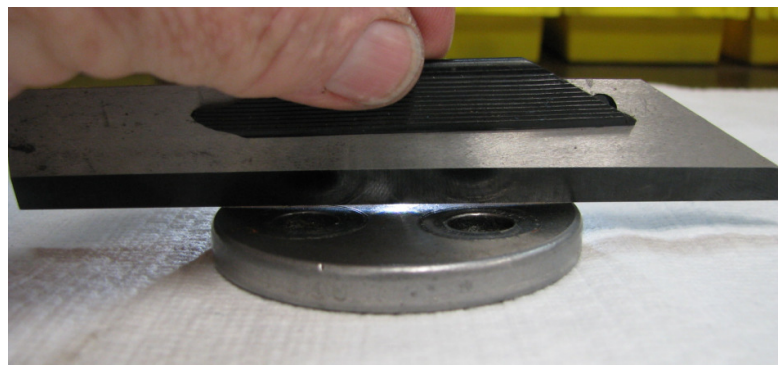
Use a straight edge

Figure 3: End plate.

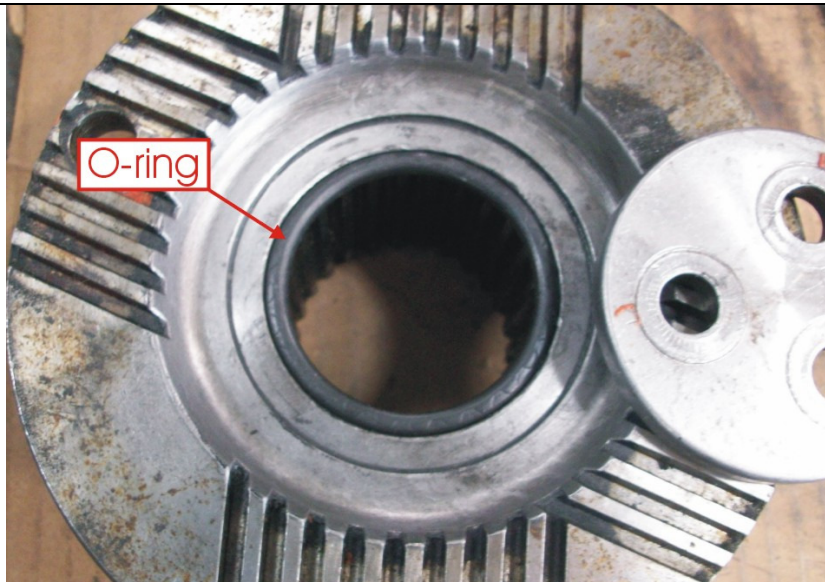
Figure 4: O-ring.

7. Inspect the gearbox output flange o-ring (PN 6403696) underneath the endplate, replace if damaged. See Figure 4.

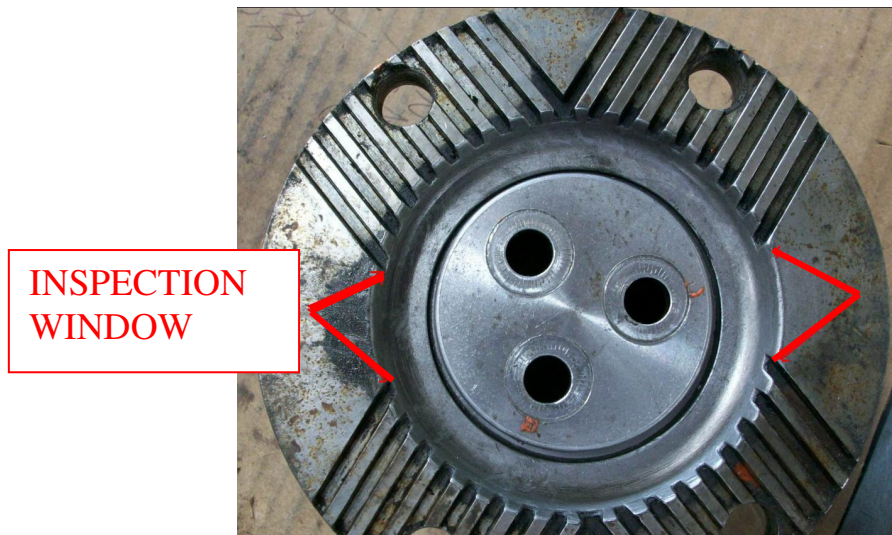
Figure 5: Torque marks.

8. After dismounting and before new of mounting of the gear flange bolts (PN 6403698), run a tap through the three output shaft bolt holes, to clear dried Loctite deposits.
9. Apply Loctite 262 to threads of new bolts (PN 6403698) and install in place of the old bolts with the o-ring (PN 6403696) and endplate back in place also. Torque bolts to 63 ft-lbs.
10. Mark hardware with a torque stripe. Ensure that the torque stripes are positioned so that they are clearly visible for external inspection through the small inspection windows between the cross-tooth flanges of the driveshaft and gearbox output flange. See Figure 5.
