# RECALL CAMPAIGN BULLETIN

NTB11-079 August 22, 2011

# VOLUNTARY SAFETY RECALL CAMPAIGN 2012 ALTIMA AND NV; AIR BAG CONTROL UNIT

**CAMPAIGN I.D. / NHTSA #**: PC100 / 11V-408

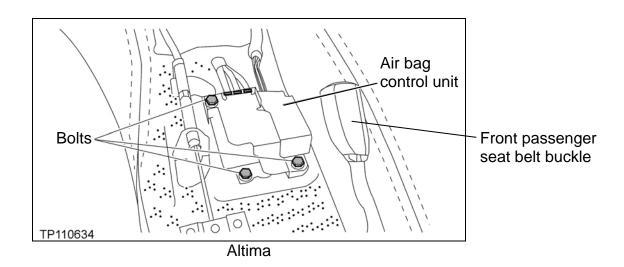
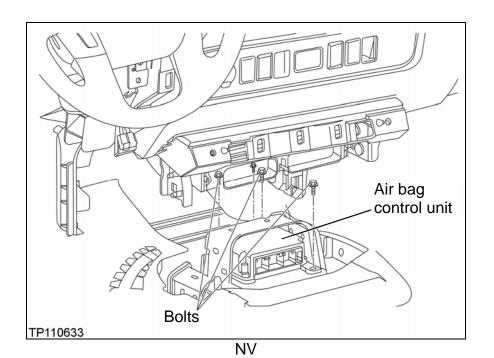
Nissan is conducting a Voluntary Safety Recall Campaign on a small number of Model Year 2012 Nissan Altima vehicles manufactured between 6/15/11 and 6/21/11; and NV vehicles manufactured between 6/23/11 and 6/28/11 to replace an out-of-specification Air Bag Control Unit (ACU).

- Follow all cautions, warnings, and notes in the Electronic Service Manual (ESM) when working on or near a Supplemental Restraint System (SRS), such as an airbag.
- Before servicing the SRS, turn the ignition switch OFF, disconnect both battery terminals, and wait at least three minutes.
- . Always work from the side of an air bag module. Never work in front of it.
- Never use air tools or electric tools for servicing.
- 1. Replace the air bag control unit (air bag diagnosis sensor unit).

- Before disconnecting the air bag sensor unit harness connector, be sure to disconnect the harness connector of each air bag module and pre-tensioner seat belt to prevent air bag deployment by static electricity.
- Do not use old bolts after removal; replace with new bolts.
- Refer to the RESTRAINTS>section SR>DIAGNOSIS SENSOR UNIT Removal and Installation area in the appropriate ESM (Electronic Service Manual) for additional important information.
