SIB 63 06 11

2025-02-20

**RECALL 11V-438: REPAIR GROUND CABLE FOR THE OUTER TAILLAMPS**

E-Series	Model Description	Production Date
E46	3 Series Sedan	9/01/2001 – 02/01/2005

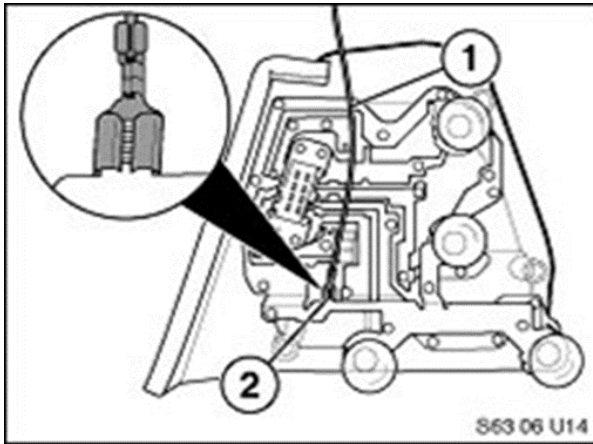
1. Check the operation and functionality of both outer taillamps (parking lights, turn signals, and brake lights).

2. If both taillamps are functioning as designed, proceed to step 5. If both taillamps are not functioning as designed, proceed to step 3.

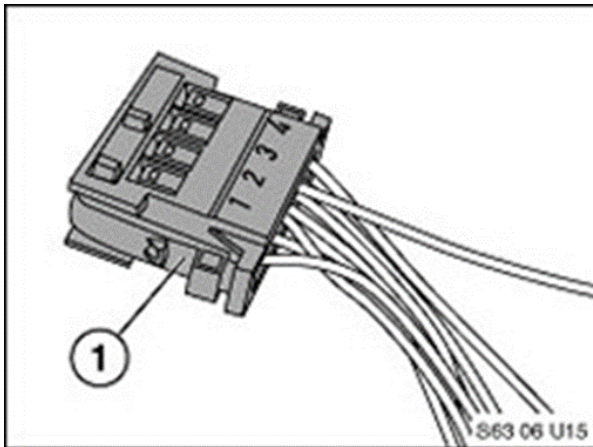
3. If the lights within either taillamp assembly are not functioning, inspect the wiring harness, connectors, and pins for signs of thermal damage (left- side connector X319 and right-side connector X318).

- If thermal damage is found, continue to step 4.

4. Replace the 8-pin connector socket housing and all 7-pins for the side that is malfunctioning.

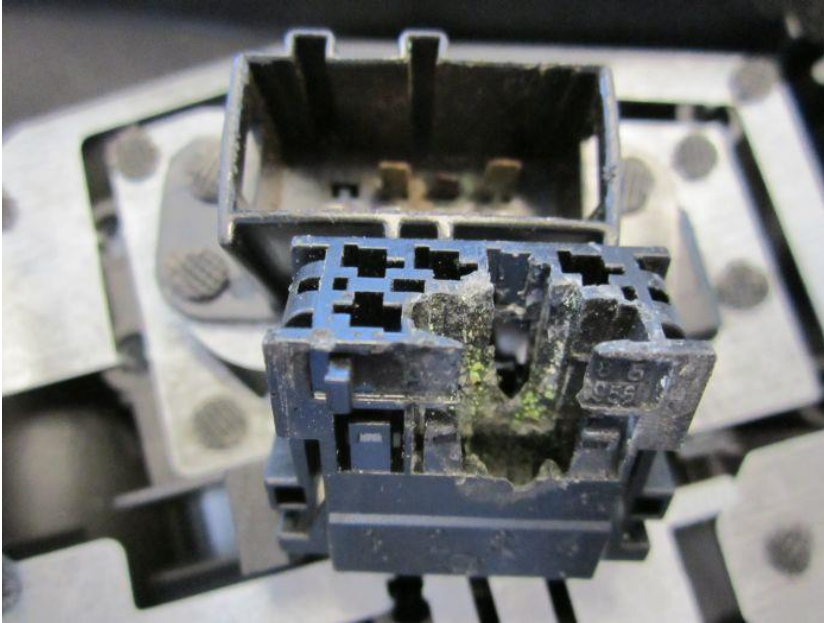
**Q:** The technician, upon inspection, determines there is thermal damage to the tail lamp bulb socket housings and corresponding wire harness connectors as shown below; what should the technician do?

**A:** The technician is to perform the applicable repair procedure outlined in SI B63 06 11.

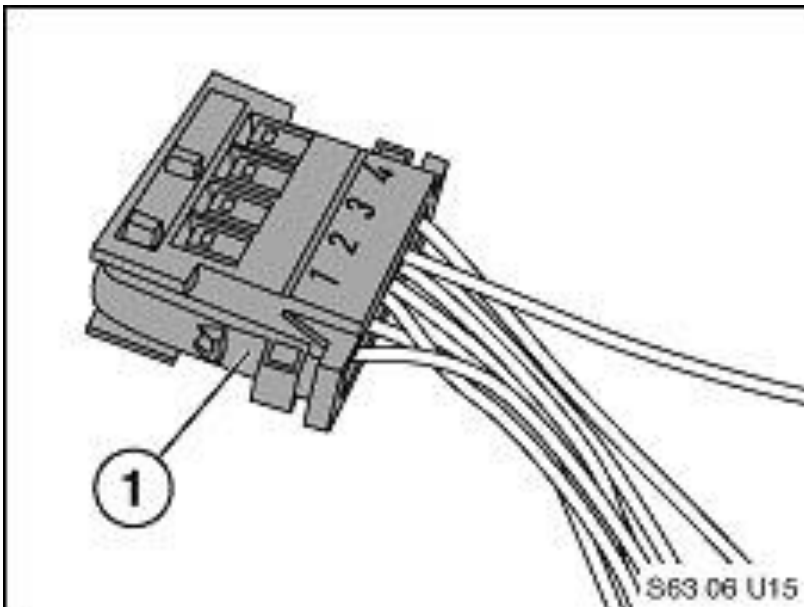
Based on the type of thermal damage shown in the picture above:

This repair kit provides a **supplementary/additional ground wire circuit** for the rear lamp to complete the open ground circuit that resulted from thermal damage to the tail lamp bulb socket housing connector(s) (X338 and X339).

The technician will first replace the 8-pin wire harness connector housing (X319/X318) and all 7-pin connectors on the malfunctioning side(s) only.

**NOTE:** It is important to also clean the electrical contacts of the tail lamp bulb socket housings, to ensure there is a good connection with the pins of the wire harness connectors (newly installed or existing, as applicable).

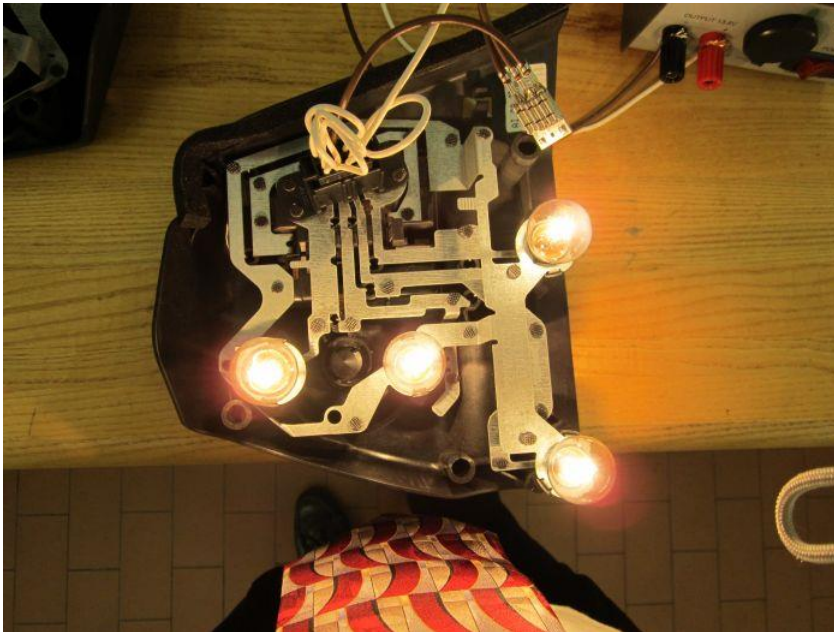
As shown, after properly performing the applicable Recall repair procedure, all light bulbs are now functioning properly.

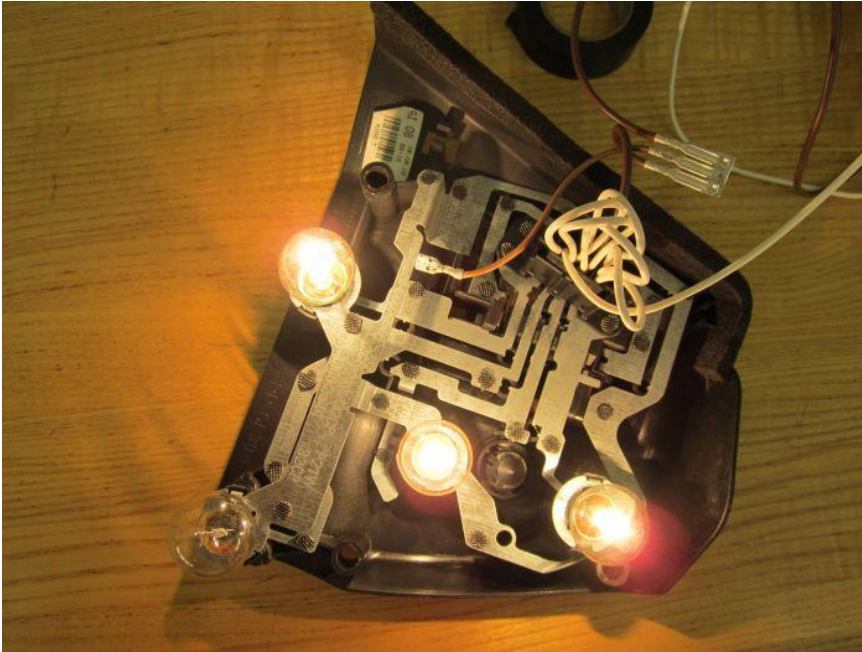
**Q:** After performing the Recall, the technician finds one or more light bulbs are still not working. How is this situation handled?

**A:** Due to the age of the vehicle, one or more light bulbs may be burnt or worn out.

Replacing light bulbs for this reason is not covered under this Recall.

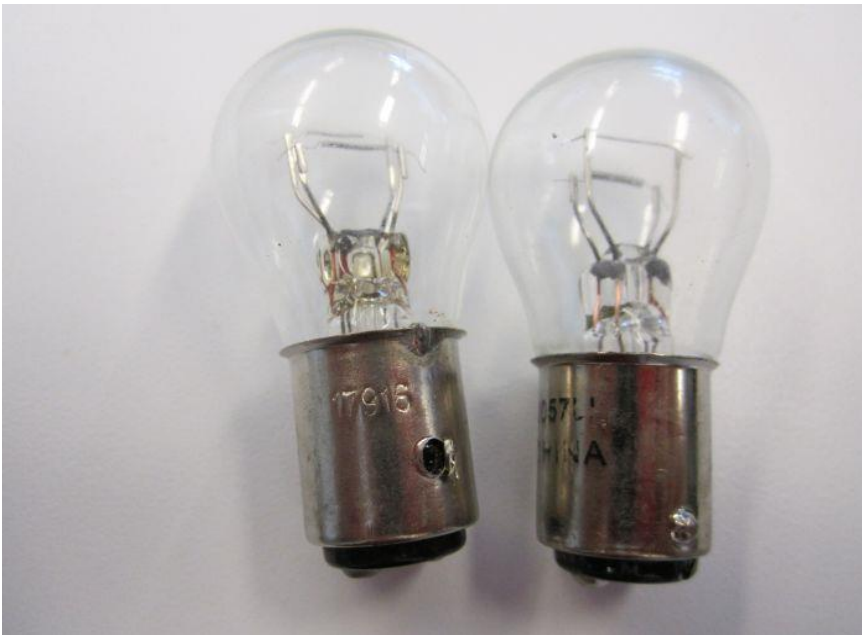
Please also check and confirm that all the installed light bulbs are the correct type.

Replacing light bulbs, for example replacing a double filament bulb type to the correct single filament bulb type, is not covered under this Recall.
