# Safety Recall

### Code: 26G8

**Subject: 2011-2012 Jetta Sedan (6<sup>th</sup> Generation)  
Accessory Exhaust Tips (Port-Installed)**

December 15, 2011

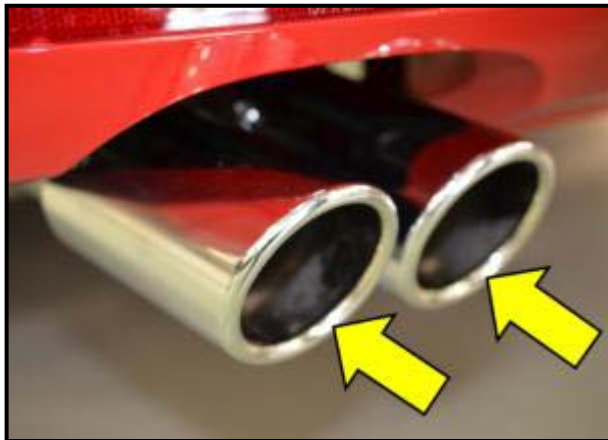
- ← Inspect for presence of accessory exhaust tips <arrows>
- If accessory exhaust tips <arrows> are present, **continue to Section C to remove exhaust tips**
- If accessory exhaust tips <arrows> are NOT present, **continue to Section E to install campaign label**
