GROUP Campaign	MODEL 2007/08MY Rondo (UN), 2006/08 Optima (MG)
	NUMBER 094	DATE February 2012
SAFETY RECALL CAMPAIGN		
SUBJECT: RONDO & OPTIMA CLOCK SPRING ASSEMBLY REPLACEMENT (SC094)

Rondo & Optima Clock Spring Assembly

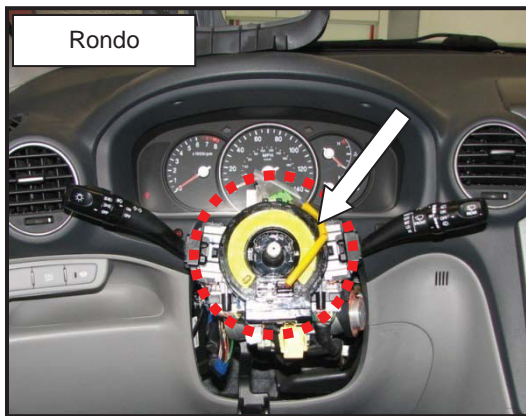
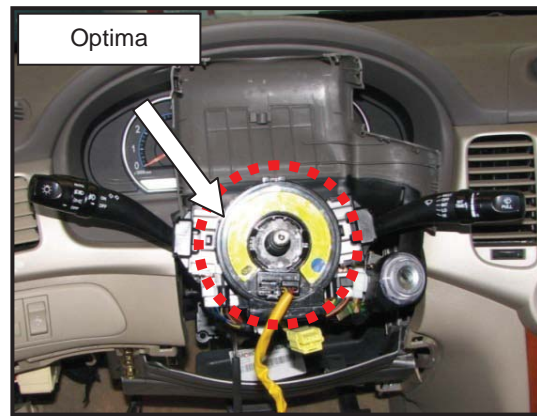
This bulletin provides information relating to the replacement of the clock spring assembly in Rondo vehicles produced from September 13, 2006 to March 21, 2008 and Optima vehicles produced from September 29, 2005 to January 29, 2008. There is a possibility that the clock spring contact assembly may become worn over time. If the clock spring contact assembly becomes damaged, it can cause high electrical resistance, which could prevent deployment of the driver's air bag in certain frontal collisions. If this condition occurs, the "AIR BAG" warning lamp will illuminate.
