Audi

# Safety Recall

Code: 23J8

Subject: 2010-2012 Model Year A3  
Diesel Fuel Injection Lines

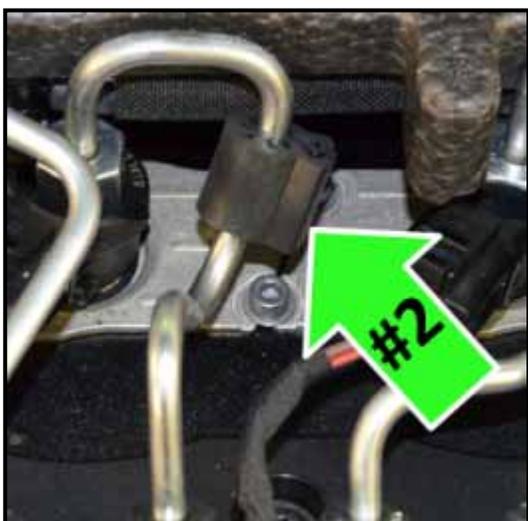
In U.S. specific application modes<sup>1</sup> of the 2.0L TDI Common Rail Diesel engine/ Clean Diesel engine (engine codes CJAA and CBEA; emissions related de-NOx and de-SOx regeneration cycles) the fuel injection pulses could coincide with the natural frequency of the injector line #2 in specific load and RPM conditions. This resonance creates additional stress on the fuel line which a small number of parts (based on the statistic spread of line strength) cannot withstand over its lifetime.

As a contributory factor, one supplier has used tube material with scratch marks from a grinding process during certain production periods which were installed in vehicles during the following production months: December 2008, January-February 2009, October 2009, March-April 2010 and September-December 2010. Injector lines using this material exhibit a significantly higher failure rate.

Due to the possible resonance condition, single fuel injection lines could develop small cracks which could lead to fuel leakage. Leaking fuel, in the presence of an ignition source, may lead to a fire.

⇐ Install fuel line Damper (03L 130 118) in the center of #2 fuel line as shown <arrow>

**!** Note:  
It is critical that the Damper is placed in the center of fuel line in the area as shown <arrow>

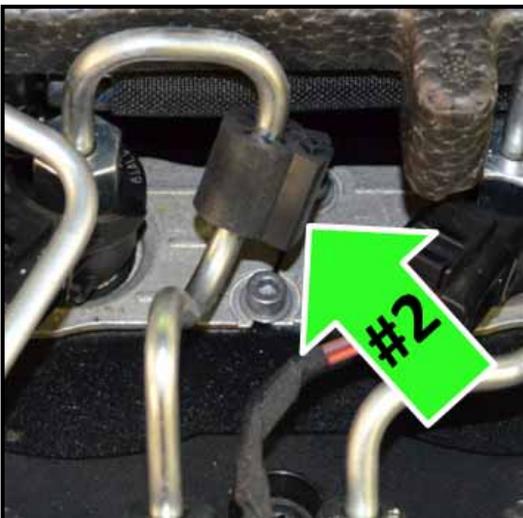
As a contributory factor, one supplier has used tube material with scratch marks from a grinding process during certain production periods which were installed in vehicles during the following production months: December 2008, January-February 2009, October 2009, March-April 2010 and September-December 2010. Injector lines using this material exhibit a significantly higher failure rate.

Due to the possible resonance condition, single fuel injection lines could develop small cracks which could lead to fuel leakage. Leaking fuel, in the presence of an ignition source, may lead to a fire.

⇐ Install fuel line Damper (03L 130 118) in the center of #2 fuel line as shown <arrow>

It is critical that the Damper is placed in the center of fuel line in the area as shown <arrow>
