Safety Recall

Code: 23J8

**Subject: 2010-2012 Model Year A3
Diesel Fuel Injection Lines**

October 4 2011

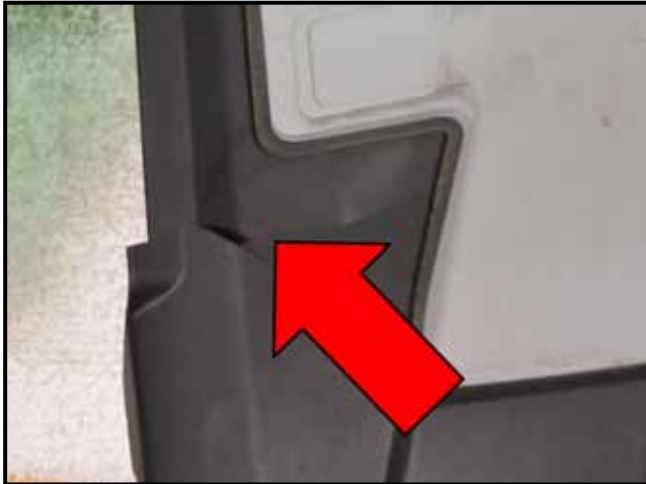
Example of damaged engine cover <arrow> due to improper removal. This type of damage is not covered under this action

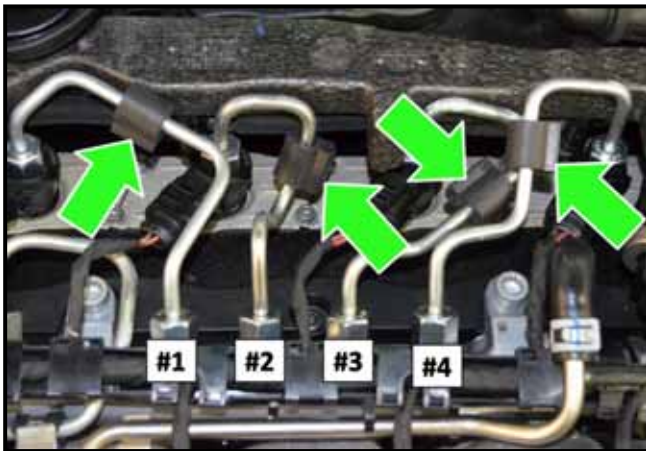
- If Dampeners <arrows> are already installed, WORK COMPLETE
- If Dampeners <arrows> are not installed, continue work procedure

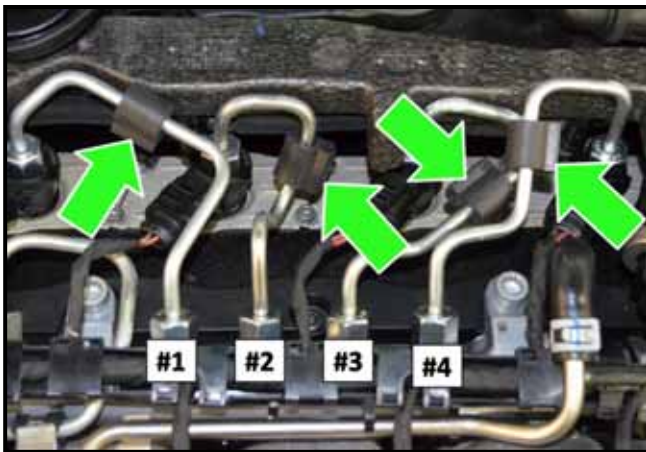
Picture on left shows overview of each dampener located properly. Ensure dampeners are located properly as shown <arrows>
