### 11 01 12 (RR04)

**Title: Recall Campaign 11V-522: Replace the Auxiliary Coolant Pump for Turbocharger (KIT- 01)**

**Affected cars:** Rolls-Royce Ghost models produced between 01/09/2009 and 01/10/2010

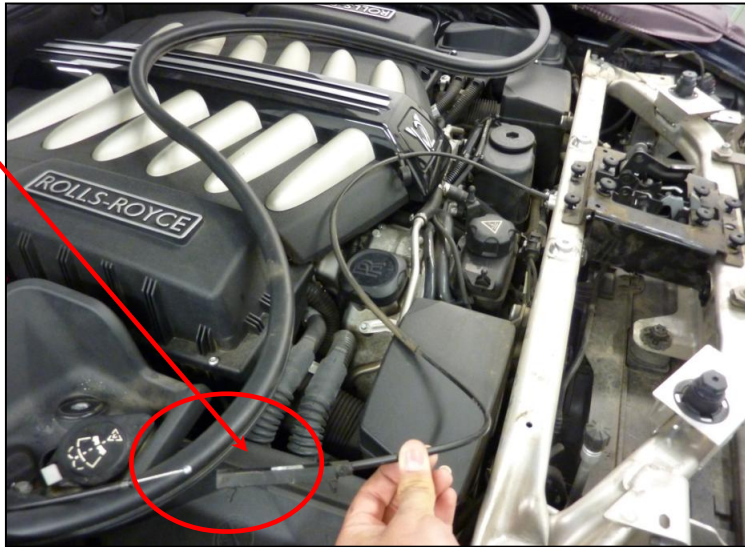
Figure 1, circled above, shows bonnet catch/ lock bridge Bowden cable disconnected

Document Number	Document title	Comments
51 76 ...	Removing and installing/replacing front cover for engine compartment	No comments
51 11 ...	Removing and installing/replacing upper radiator grille cover	No comments
51 11 ...	Removing and installing/replacing side left or right radiator grille frame	No comments
51 13 145	Removing and installing/replacing retraction mechanism of Spirit of Ecstasy	No comments
51 13 000	Removing and installing/replacing the centre radiator grille	<b>Note:</b> Do not remove front bumper trim (51 11 156 Removing and installing front bumper trim)
51 64 026	Removing and installing/replacing upper front connection (cross member)	<b>Note:</b> Disconnect bonnet catch/ lock bridge Bowden cable as shown in Figure 1 below

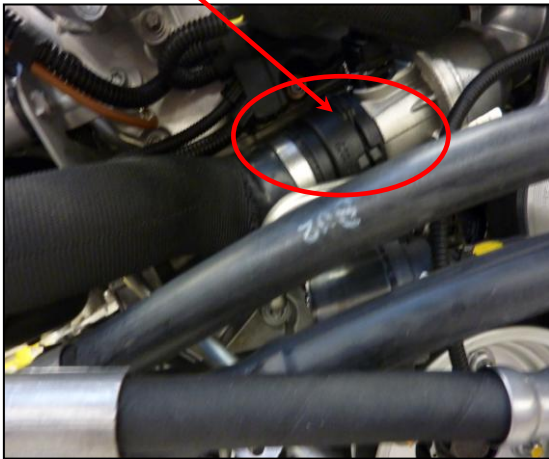
Figure 2

Figure 2, above left, shows the lower coolant hose fitted.

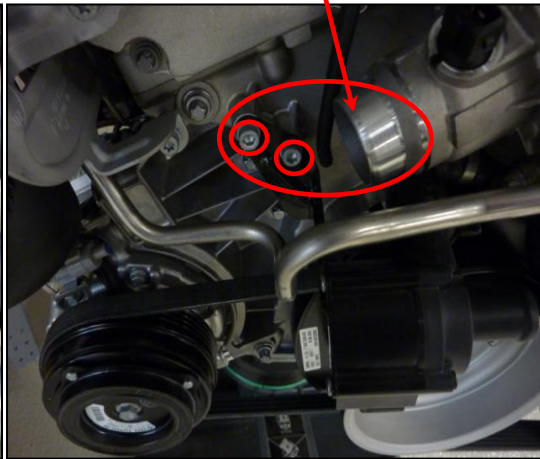
Figure 3

Figure 3, above right, shows the lower coolant hose removed and auxiliary water pump bracket fixings.

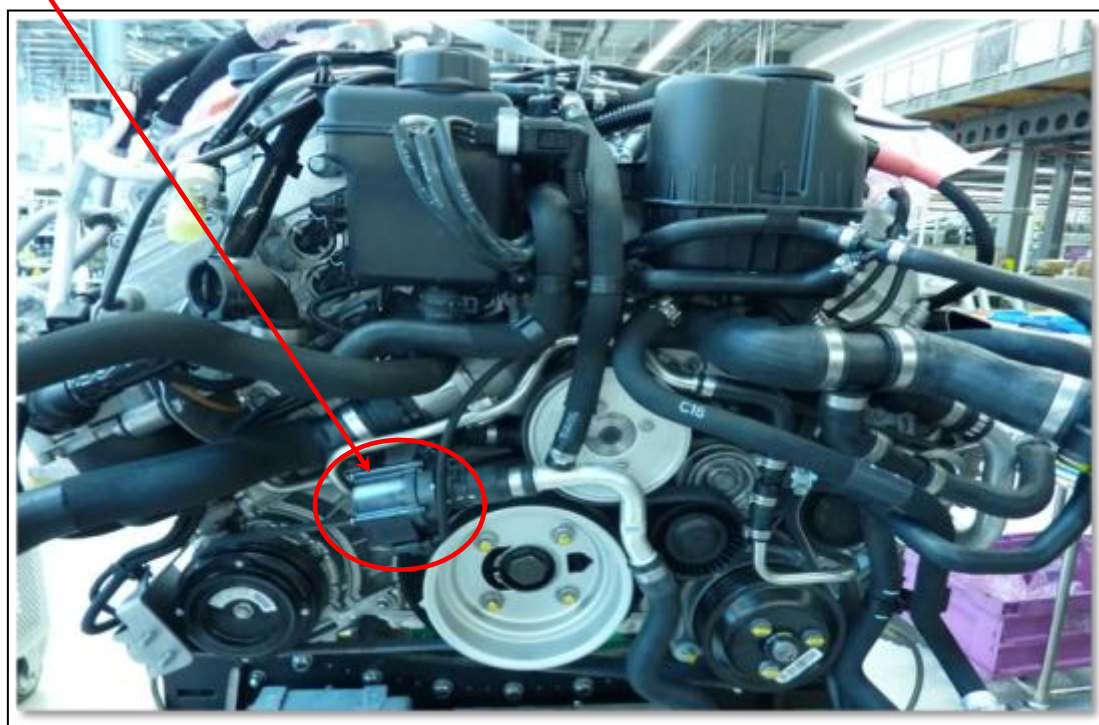
Figure 4, circled above, shows the location of the auxiliary water pump, fitted to the front of the N74R engine.

<b>51 47 490</b>	Removing and installing/replacing front underbody protection	No comments
<b>51 75 051</b>	Removing and installing/replacing distribution channel	No comments
<b>17 11 035</b>	Removing and installing/renewing fan cowl with electric fan (N74R)	No comments
<b>11 53 000</b>	Removing and installing/replacing auxiliary water pump for exhaust turbocharger (N74R)	<b>Note:</b> Do not remove charge air cooler expansion tank (17 13 020 Removing and installing/replacing charge air cooler expansion tank) <b>Note:</b> To gain access to the auxiliary water pump bracket fixings, the lower coolant hose needs to be removed as shown in Figure 2 and 3 below <b>Note:</b> Location of the auxiliary water pump on photo R11 5157 is incorrect. See correct location for N74R in Figure 4 below.
