SB-0001 Orion VII/NG Li-Ion ESS Mitigation Measures

Bulletin Number:	SB-0001	Revision:	A	EIC Number:	N/A	Std. Repair Time:	N/A
Application:	Orion VII and Orion VII NG model hybrid buses with Li-Ion Energy Storage Systems.						
Classification:							
Information Letter	<input checked="" type="checkbox"/>	Parts Bulletin	<input type="checkbox"/>	Service Manual Update	<input type="checkbox"/>	Operator's Manual Update	<input type="checkbox"/>

This Service Bulletin provides the BAE Systems-suggested mitigation measures to reduce potential/probability of double-ended ground faults and possible Lithium-Ion Energy Storage System (ESS) thermal events on an Orion VII or Orion VII NG model hybrid bus.

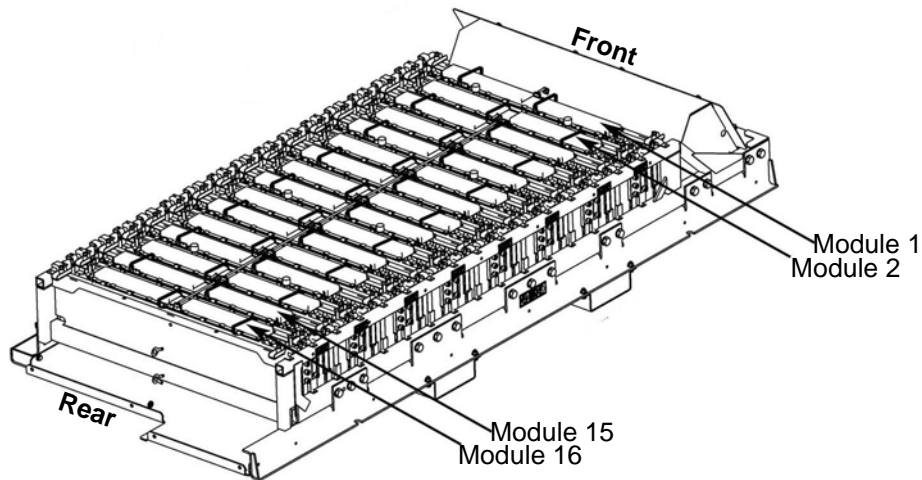
Figure 1-1

Suggested mitigation measures to reduce potential/probability of double-ended ground faults and possible Li-Ion ESS thermal events:

- a. Remove modules 1, 2, 15, and 16 (**see Figure 1-1**) to clean the ESS frame module support rails.
 - b. Clean the bottom surface of each of the removed modules.
2. Maintenance personnel should monitor the CHECK HEV light on the driver's front dash panel. If illuminated, check for active fault(s).
