# Recall Bulletin

**SUBJECT:** Power Vacuum Brake Boost Pushrod Retention Nut Torque - Inspect

**MODELS:** 2012 Cadillac CTS

GM Recall #11318

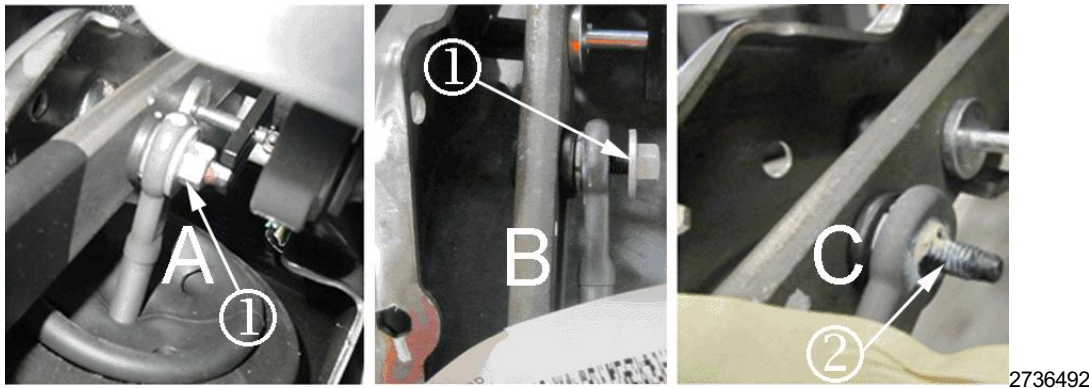
General Motors has decided that a defect, which relates to motor vehicle safety, exists in **certain** 2012 model year Cadillac CTS vehicles. Some of these vehicles have a condition in which the power vacuum brake boost pushrod retention nut may not be torqued to the proper specification. If the nut is not torqued to the proper specification, the nut could loosen and allow the pushrod to separate from the brake pedal. This could result in a loss of ability to brake and possible crash without prior warning.

(1) Brake Booster Actuator Rod Nut (2) Missing Nut  
 (A) Nut Present and Tightened (B) Nut Loose (C) Missing Nut

- Reach up the brake pedal and feel for the brake booster actuator rod nut. Determine if the brake booster actuator rod nut is present and tightened to 9 N·m (80 lb-in).
  - If the brake booster actuator rod nut is present and tightened to 9 Nm (80 lb-in), no further action is required.
  - If the brake booster actuator rod nut is missing, replace the nut and **tighten it to 9 N·m (80 lb-in)**.
  - If the brake booster actuator nut is loose or NOT tightened to 9 Nm (80 lb-in), **tighten the nut to 9 N·m (80 lb-in)**.
