## Safety Recall

**Subject: MERITOR FRONT AXLE WHEEL END NUT PACK INSPECTION**

**Bulletin: RCB-012-11**

**Affected Models: Certain 2012 MY NE8J, NJ8J, NV8J models equipped with Meritor front axles.**

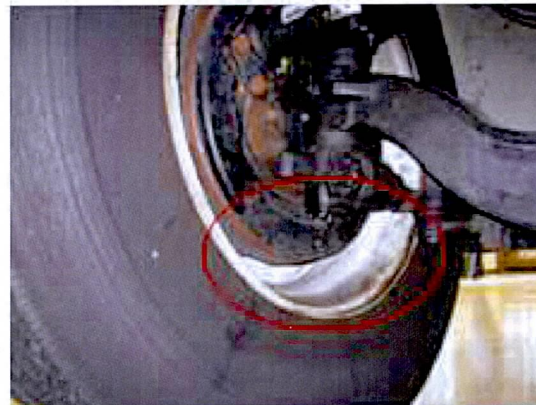
6. Visually inspect the inner wheel bearing seal area on both the driver and passenger sides for evidence of a seal leak. Document your results.

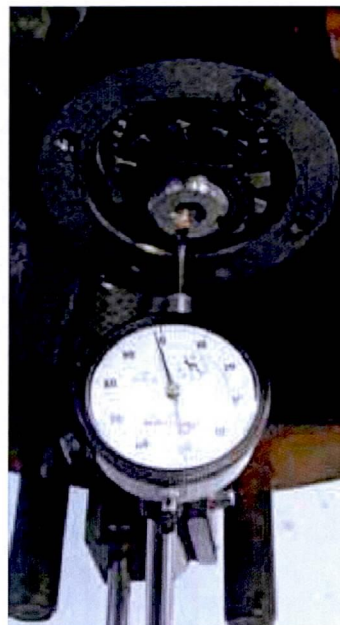
8. Using a dial indicator, measure and record the wheel bearing end play for both the driver and passenger side wheel end. Does the wheel bearing end play fall within the end play specification?

**Wheel Bearing End Play Specification:**

0.001" - 0.005" (0.0254 - 0.0127 mm).

Proceed to the "Front Axle (MFS) Repair Procedure".

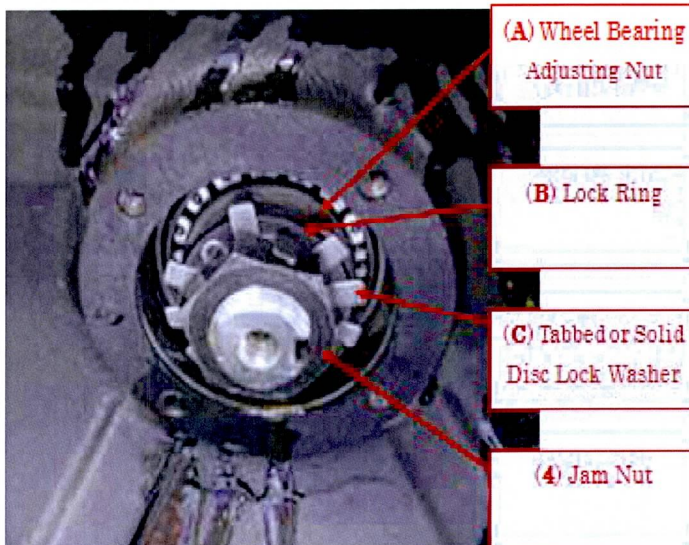
9. Visually inspect to confirm that the 4 components of the wheel bearing nut pack are installed on both the driver and passenger side wheel ends.

(A) - Wheel Bearing Adjusting Nut

(B) - Lock Ring

(C) - Tabbed or Solid Disc Lock Washer

(D) - Jam Nut

Proceed to the "Front Axle (MFS) Repair Procedure".

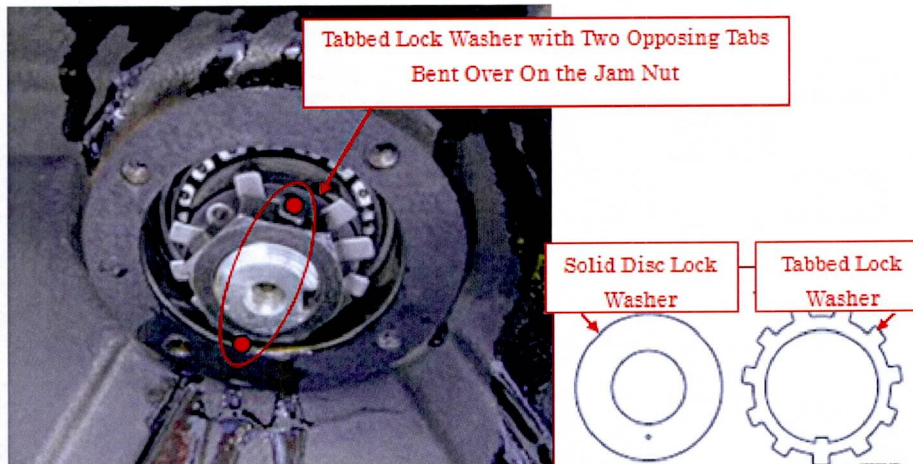
10. Inspect to confirm that tabbed lock washer has two opposing tabs that are bent over on the jam nut. In rare cases, the lock washer could be a solid disc type. If a solid disc lock washer is installed, one tab will need to be bent over on the jam nut. Is the locking tab correctly installed and properly bent down over the jam nut?

Proceed to the “**Front Axle (MFS) Repair Procedure**”.
