ITB11-058a

## VOLUNTARY SAFETY RECALL CAMPAIGN 2011 - 2012 G37 COUPE POWER WINDOW SWITCH

CAMPAIGN ID #: P1247  
NHTSA #: 11V-538  
APPLIED VEHICLES: 2011 - 2012 G37 Coupe (CV36)

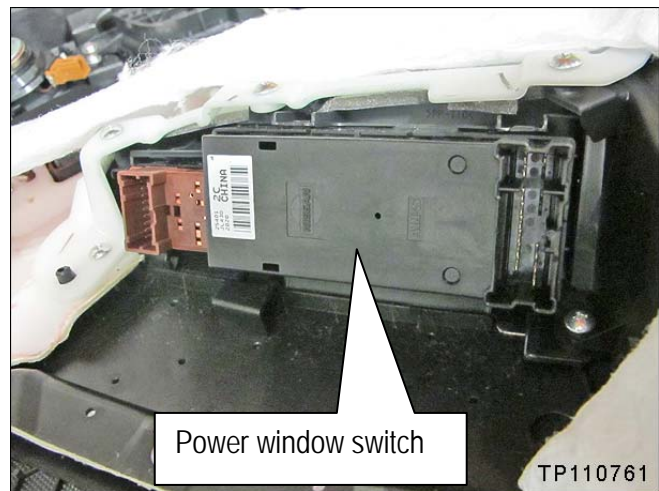
Figure 11

Certain specific Model Year 2011-2012 G37 Coupe vehicles may have been equipped with an out-of-specification power window switch. This may cause the auto reverse feature to not work properly and could increase the risk of a pinch injury.

15. Remove the power window switch from the finisher.

- Use a small flat blade screwdriver.
- Release 4 pawls – 2 on each side.

16. Install the new power window switch.

- Use the new switch listed in the Parts Information.
- Make sure the new switch is completely snapped in position.
