Model: Federal 2011MY Elise - Limited VIN Range
Within Port Facilities & Dealer Stock

Number: 2011/23
USA Issue 2

Retrofitment of revised turn signal module (also referred to as a flasher relay or module) for demonstrator vehicles or inventory stock.

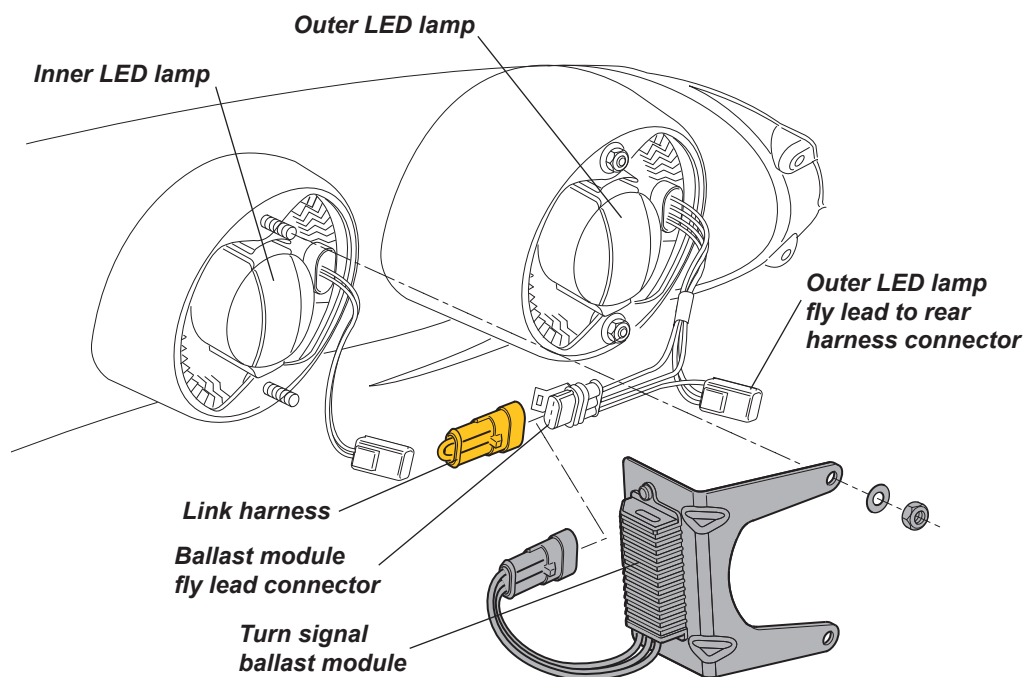
m271

1. Remove both rear RHR and LHR lamp covers located within the rear luggage compartment.
2. Inspect and confirm if there are turn signal ballast modules fixed to the inner LED lamps.
3. If ballast modules are not fitted and green colored link harnesses are connected to the fly leads of both outer LED lamps, then no further action is required. (see illustration on page 2).

1. Disconnect the harnesses of both ballast modules at their multi-plug connections to the RH & LH outer lamp fly leads.
2. Remove the M5 nyloc nuts and M5 washers securing the ballast modules to both LH & RH inner lamp assemblies.

3. Remove both modules from the vehicle and refit the inner LED lamps nuts and washers. Attach a warranty tag to the ballast modules and retain them with any other displaced warranty parts as per the current warranty procedures policy.

4. Attach a link harness to both of the outer lamp fly lead connectors.
5. Replace the turn signal module with new part number A121M0060F. The module is located in the passenger side footwell fuse and relay station. (The specific module location is listed in section MP11 of the Elise and Exige Service Notes).
