Safety Recall

Subject: STEERING ARM BOLT INSPECTION

Bulletin: RCB-013-11

Affected Models: Certain 2011 and 2012 MY NE8J Conventional model trucks equipped with Meritor front axles.

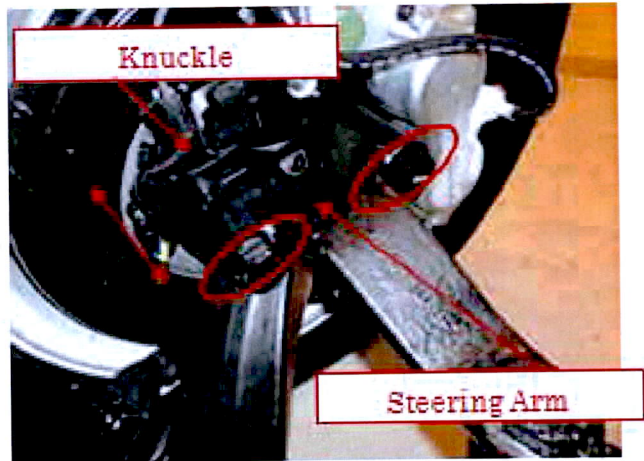
8. Visually inspect the steering arm to knuckle union. Is there any visual clearance or sign of bolt looseness indicating that the steering arm is separating from the knuckle?

Proceed to the “**Repair Procedure**”.

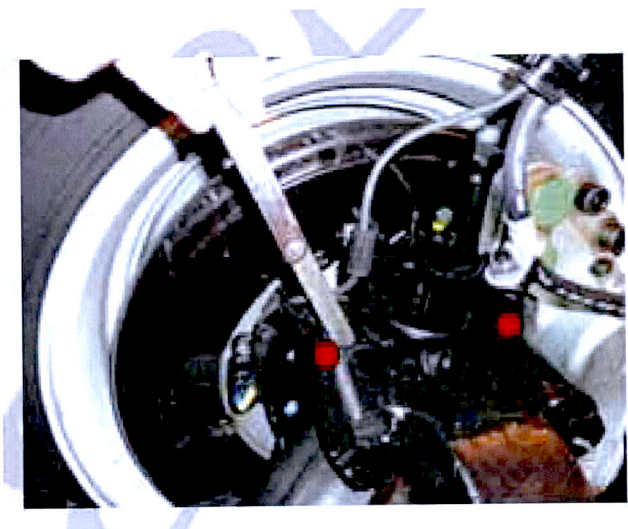
9. Use a .005” feeler gauge and try to slide it between the steering arm and knuckle mating surface. Does the feeler gauge fit between the steering arm and knuckle?

Proceed to the “**Repair Procedure**”.

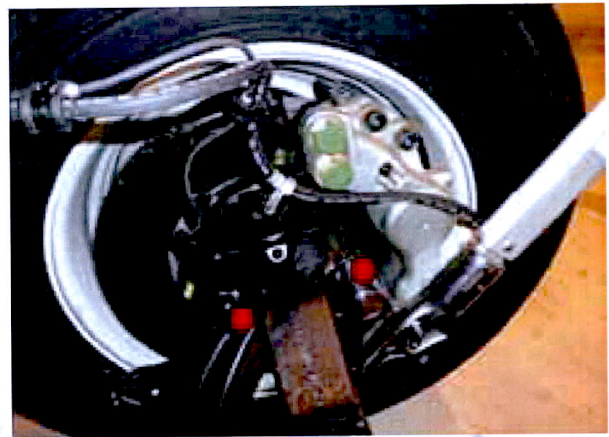
1. Using a properly calibrated torque wrench, check and document the break away torque on each of the two steering arm bolts when rotating them in the clockwise (tightening) direction. Do either of the steering arm bolts move in the clockwise (tightening) direction before reaching the specified torque value?

NOTICE: If using a properly calibrated “clicker” style torque wrench, set it to the low side of the specified torque value (360 lb.ft.). If the either of the steering arm bolts move in the clockwise (tightening) direction before reaching the minimal value Specified Torque Value (360 lb.ft.), the result of the inspection would indicate that the steering arm bolt(s) are set under the minimum required torque.

Specified Torque Value: 360-470 lb.ft.

Proceed to **Step 1** “Repair Procedure”.

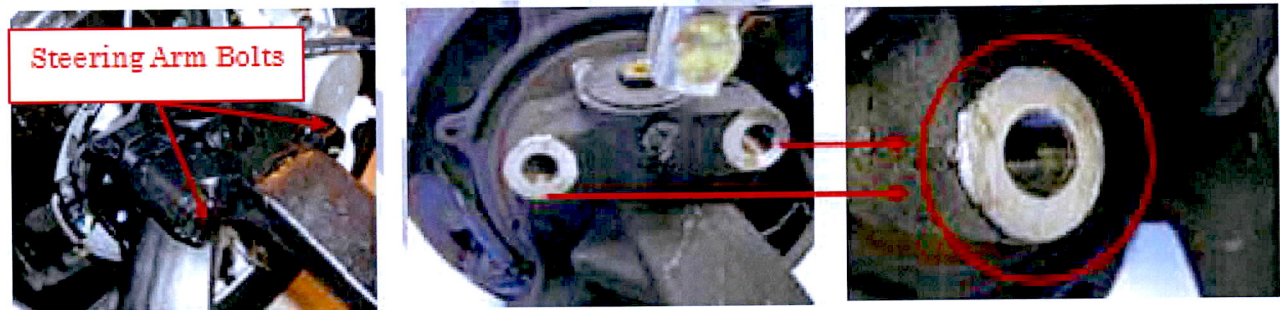
2. Remove the steering arm bolts and steering arm from the knuckle. Visually inspect the threads located on the knuckle that receive the steering arm bolts. Is there any damage to the threads on the knuckle?

Knuckle and steering arm bolt replacement is required.

Steering arm bolt replacement is required.
