File In Section: Product Recalls  
Bulletin No.: 11322A  
Date: December 2011

# Recall Bulletin

**SUBJECT:** No Warning Light or Chime When Driver Safety Belt is Not Fastened

**MODELS:** 2012 Chevrolet Colorado  
2012 GMC Canyon

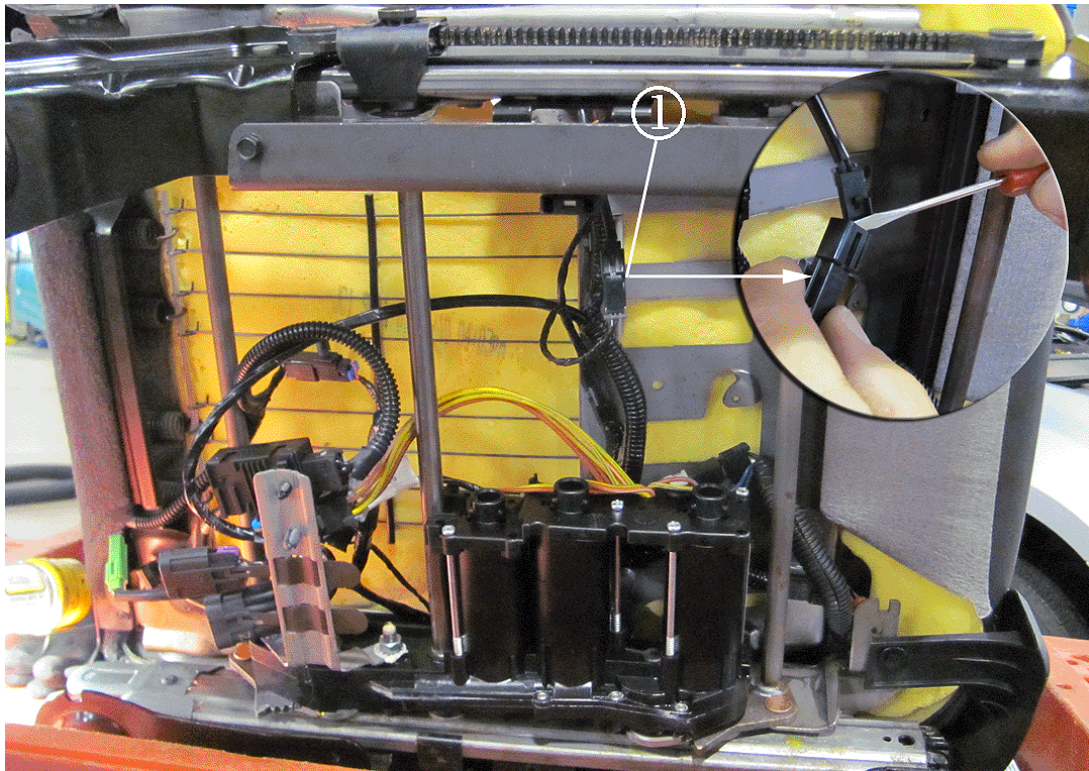
2741368

**Note:** Front bucket driver seat shown, passenger bucket and split bench seats are similar. Remove the buckle electrical connector harness from the seat frame clip if required to repair the terminals.

4. Locate the buckle electrical connector (1). The buckle electrical connector (1) is located under the seat cushion. Refer to illustration.
5. Disconnect the buckle electrical connector.
