**Re: Defect Information Report – Supplemental Report No. 2  
11V-558, FL-618, Meritor Axle Tower Bracket Welds**

## Subject: Meritor Axle Tower Bracket Welds

**Models Affected:** Specific Western Star 4900 vehicles manufactured December 14, 2010, through January 26, 2011, with Meritor drive axles.

December 2011  
FL618A  
NHTSA #11V-558  
Transport Canada #11-407

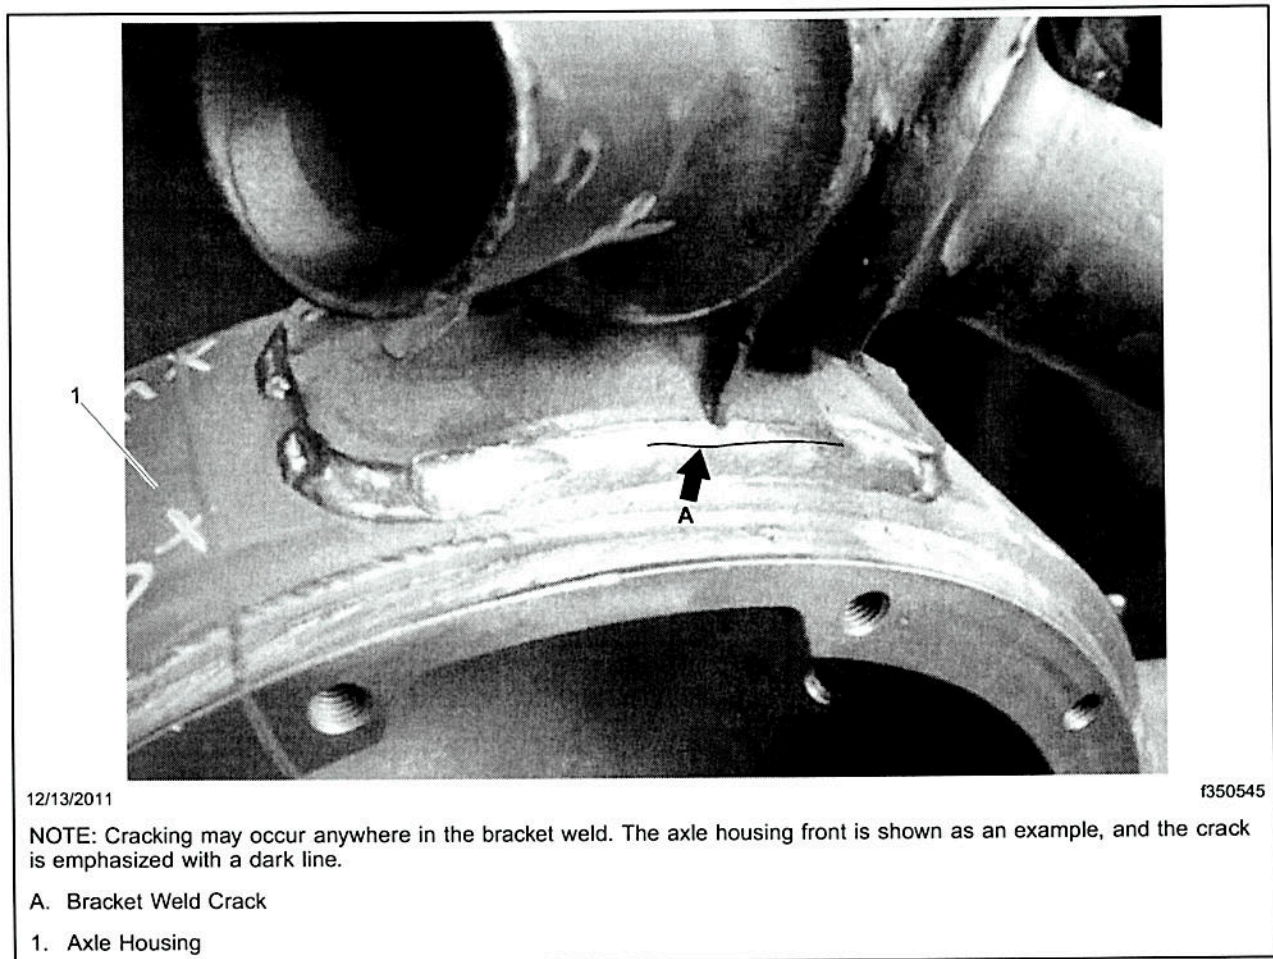
In certain drive axle assemblies, the weld that attaches a tower bracket to the housing may crack as a result of improper welding procedures. If a weld cracks, the bracket could detach, leading to a loss of vehicle control and possible vehicle crash.

3. Clean the affected region around the tower bracket, front and back. Use a cleaning solvent and wire brush to remove dirt and grease. Visually inspect for cracks around the Chalmers tower bracket weld. See Fig. 1.

Fig. 1, Bracket Weld, Cracked

4. Using a die penetrant, check the tower bracket weld for cracking. Refer to the product manufacturer's instructions for correct procedures.
5. Inspect the weld for a crack.

- If a crack is found, take a clear, detailed photo of the crack on the bracket, and email it along with the axle housing serial number, VIN, vehicle mileage, in-service date, to the OnTrac Customer Service Center at OnTrac@Meritor.com. In the email subject line, enter "DTNA Recall FL618 - Axle Welds." Then complete the "Weld Repair Procedure" in these work instructions.

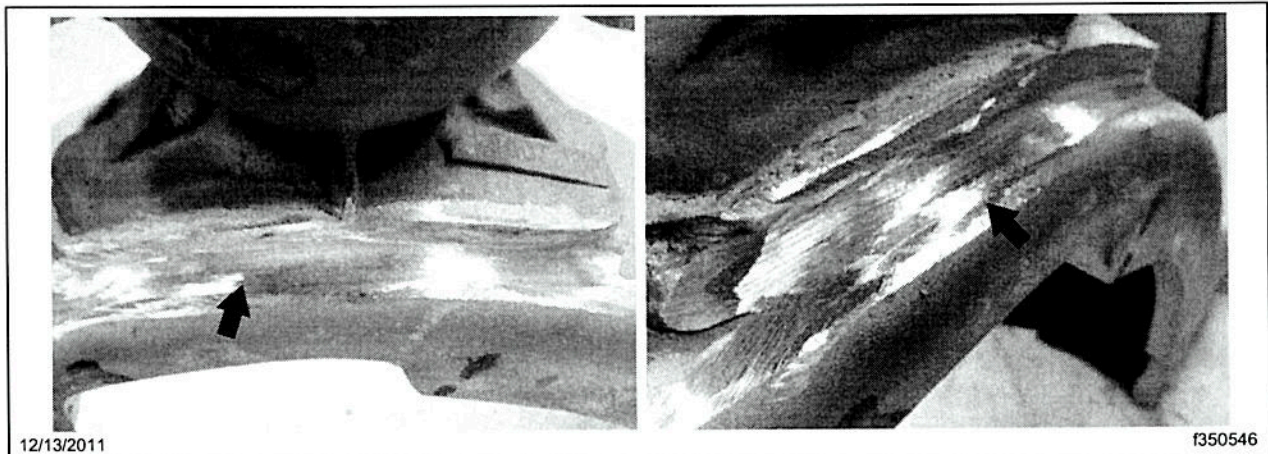
Fig. 2, Bracket Weld, Ground to Housing and Bracket Materials

1. Use a grinder to remove the cracked weld. The weld must be removed to the base housing and bracket materials. See Fig. 2.

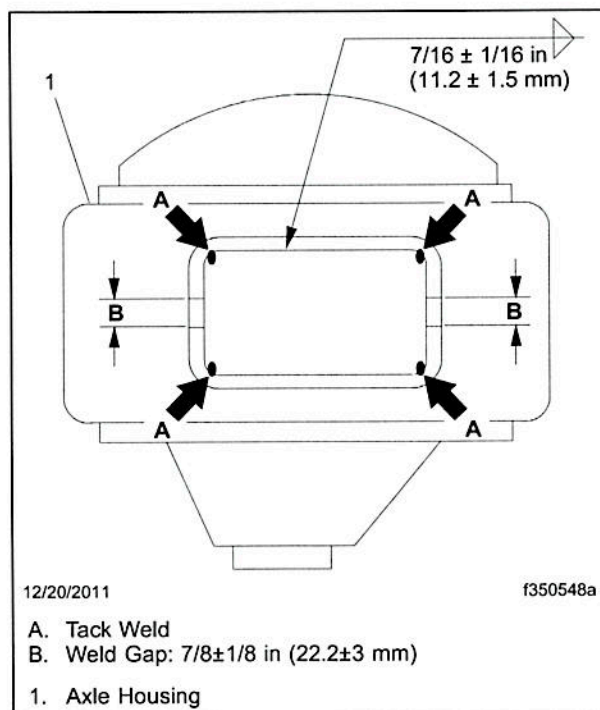
Fig. 3, New Bracket Weld, Locations and Dimensions

- Tack weld all four corners of the bracket to the housing as shown in Fig. 3.
- Repair weld the affected region following the dimensions in Fig. 3. It is important to smoothly tie in the weld with the ends. Make sure the weld covers the upper edge of tower bracket. See Fig. 4.

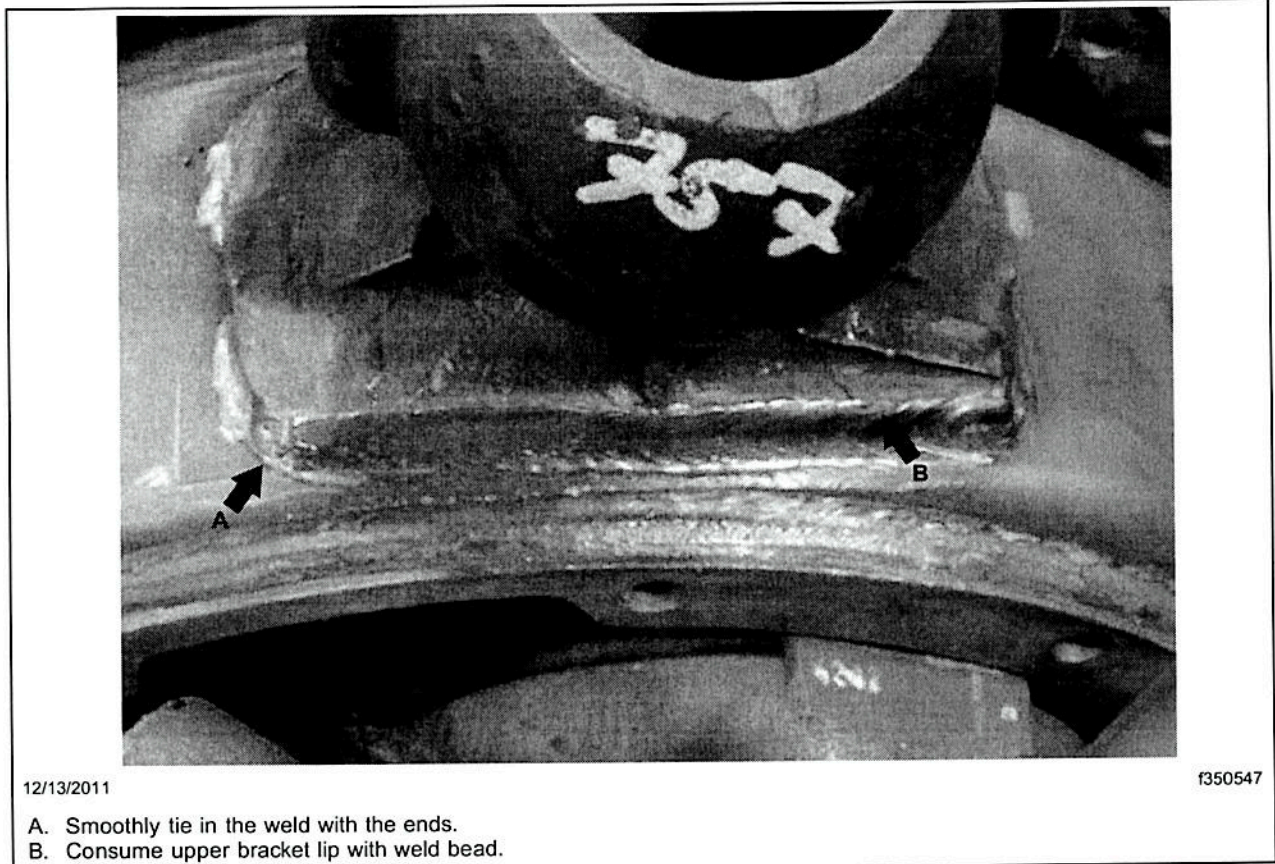
Fig. 4, New Bracket Weld, Completed
