RECALL CAMPAIGN BULLETIN

NTB11-108a

VOLUNTARY SAFETY RECALL CAMPAIGN 2010 - 2011 SENTRA POSITIVE BATTERY TERMINAL

CAMPAIGN ID #: PM180
NHTSA #: 11V-579
APPLIED VEHICLES: 2010 – 2011 Sentra (B16)

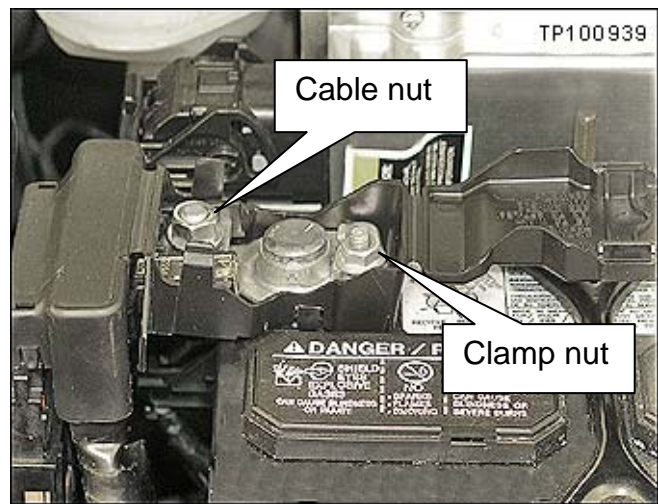
Figure 2

NOTE: This nut fastens the battery cable and fusible link assembly to the positive battery terminal/clamp.

4. Remove the cable nut shown in Figure 2.

5. Loosen the positive battery terminal/clamp nut.
